# **Protected Tree Assessment and Arborist Inventory Report LA28 Equestrian Course Grading Plan**

## **Prepared for**

Los Angeles Turf Club  
285 W Huntington Drive  
Arcadia, CA 91107  
Contact: Ms. Nicola Boon  
Phone: (760) 213 0963  
Email: niciboon@nbicassociates.com

June 2026

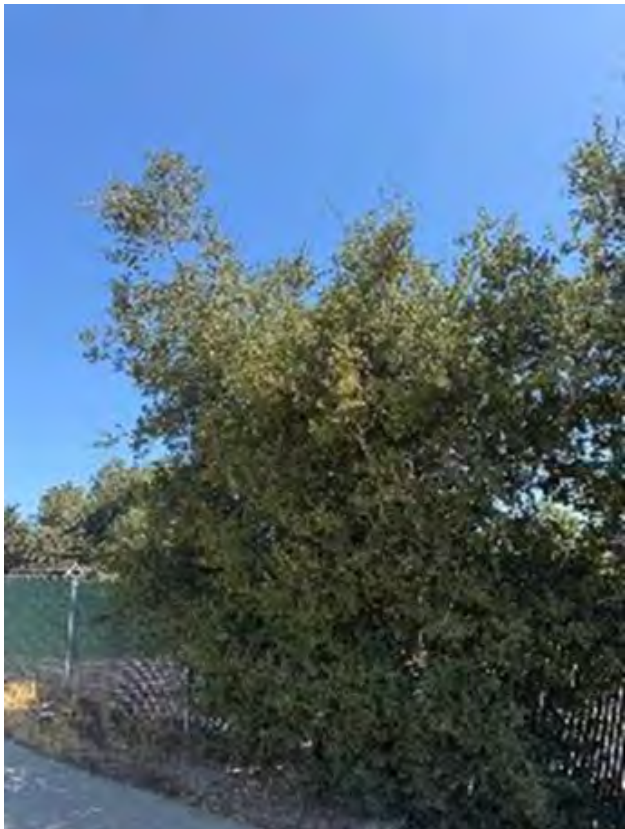
| | <p>Photograph: 1. TREE #6<br/>Species: Coast Live Oak<br/>Category: Protect in place, Avoid</p> |

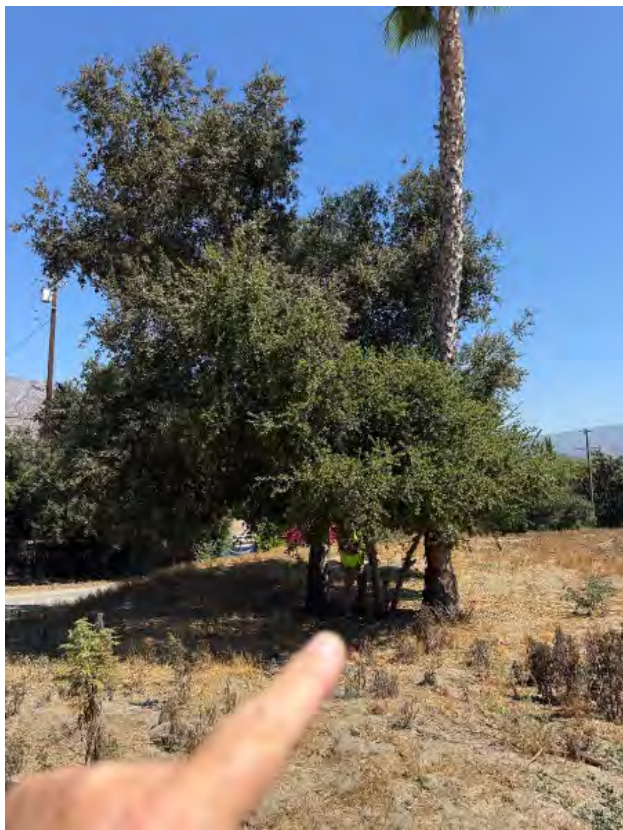
Photograph: 3. TREE #14  
Species: Coast Live Oak  
Category: TRE with Intensive Mitigation

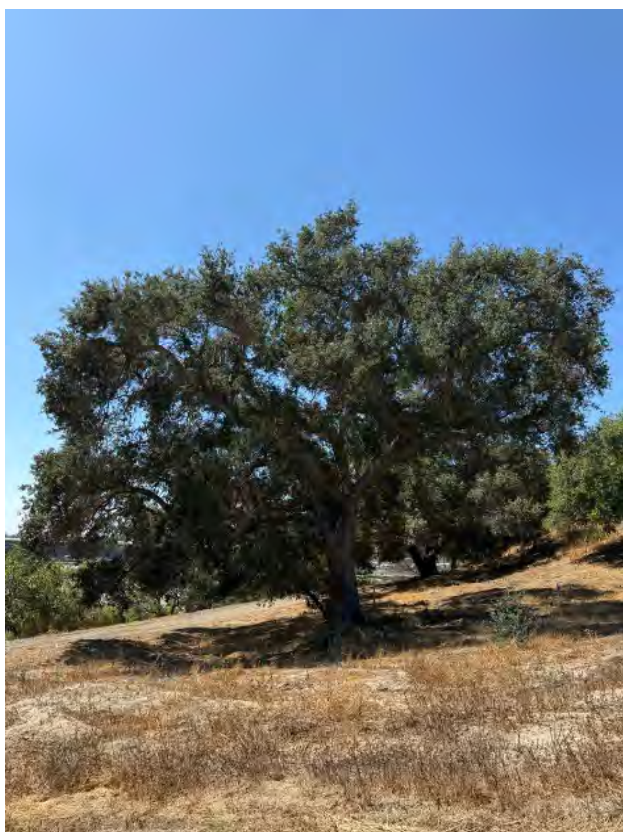
| <i>Tree</i> | <i>Common Name</i> | <i>Scientific Name</i> | <i>DSH (Inches)</i> | <i>Ht (Feet)</i> | <i>Vigor</i> | <i>Crown (Feet)</i> | <i>Density</i> | <i>Condition Factors / Notes</i> |
|---|---|---|---|---|---|---|---|---|
| 16 | Coast Live Oak | <i>Quercus agrifolia</i> | 42 | 50 | Normal | 36 | Normal | Scale insect, leaf galls; Deadwood removal, large. Trunk damage large lateral with included bark |

Photograph: 4. TREE #16  
Species: Coast Live Oak  
Category: TRH

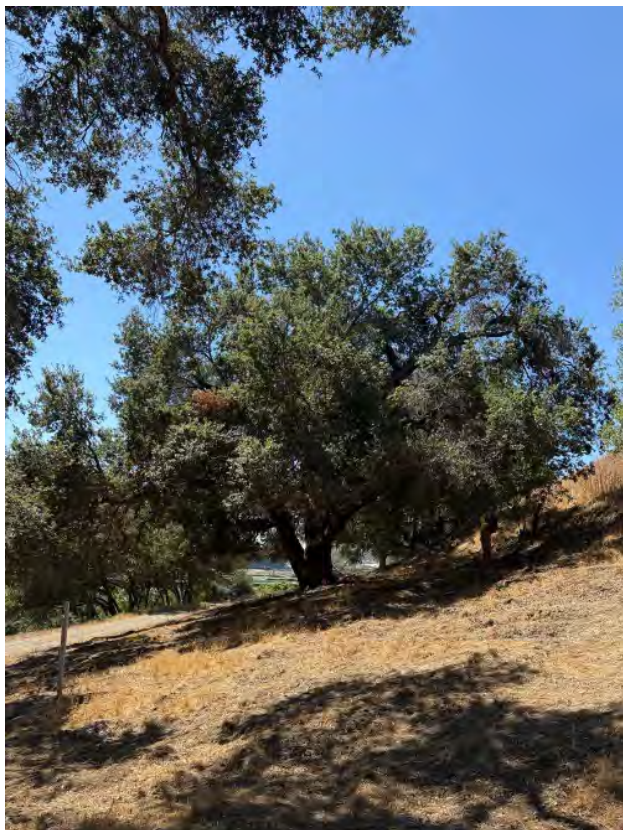
| <i>Tree</i> | <i>Common Name</i> | <i>Scientific Name</i> | <i>DSH (Inches)</i> | <i>Ht (Feet)</i> | <i>Vigor</i> | <i>Crown (Feet)</i> | <i>Density</i> | <i>Condition Factors / Notes</i> |
|---|---|---|---|---|---|---|---|---|
| 18 | Coast Live Oak | <i>Quercus agrifolia</i> | 54 | 45 | Normal | 39 | Normal | Scale insects, galls; Vigor and density normal, but tending towards low and sparse. Broken portion top |

Photograph: 5. TREE #18  
Species: Coast Live Oak  
Category: TRH

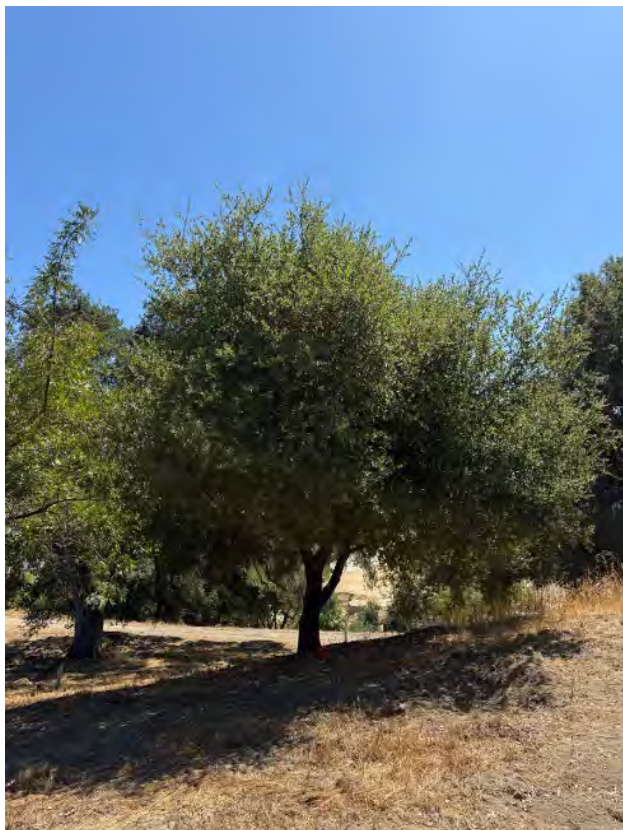
Photograph: 7. TREE #20  
Species: Coast Live Oak  
Category: TRH

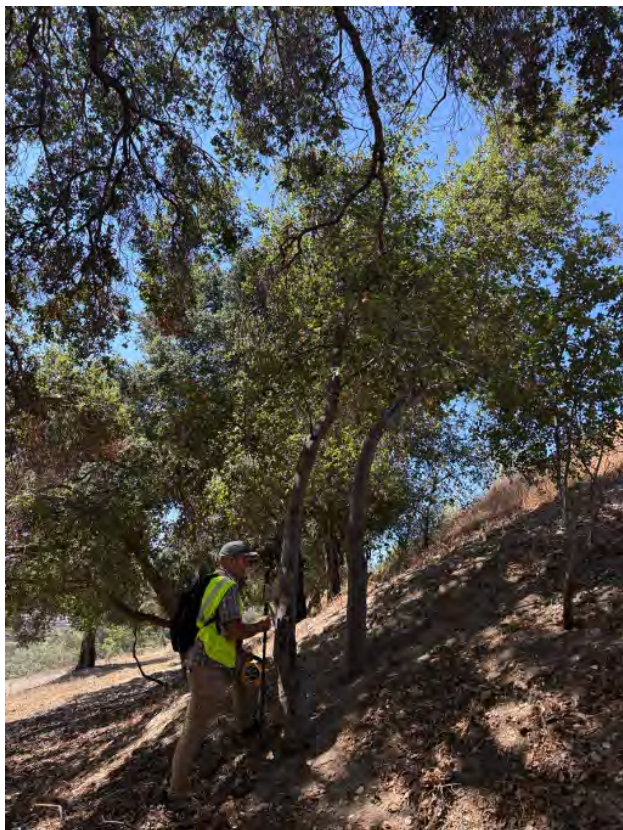
Photograph: 9. TREE #24  
Species: Coast Live Oak  
Category: TRH

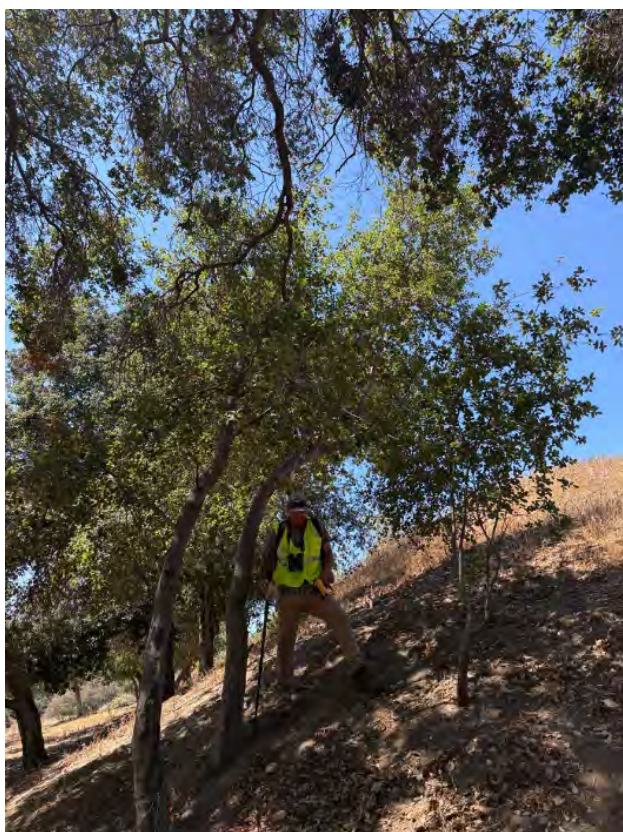
Photograph: 10. TREE #25  
Species: Coast Live Oak  
Category: TRH

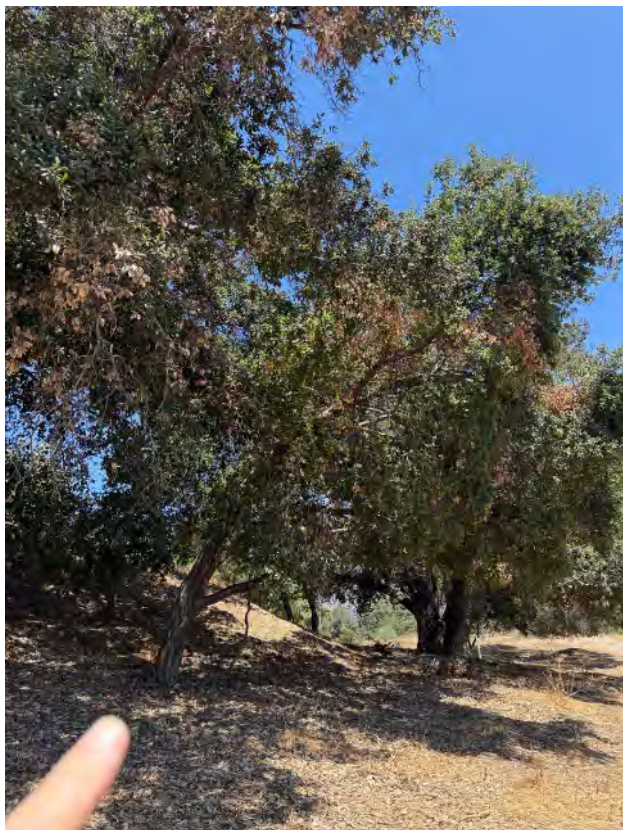
Photograph: 11. TREE #26  
Species: Coast Live Oak  
Category: Protect in place, Avoid

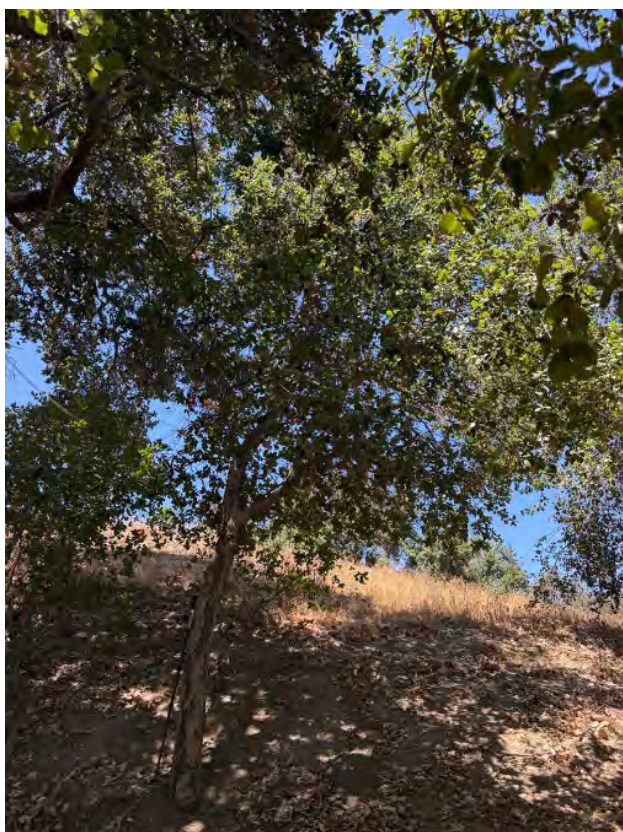
Photograph: 12. TREE #27  
Species: Coast Live Oak  
Category: TRE

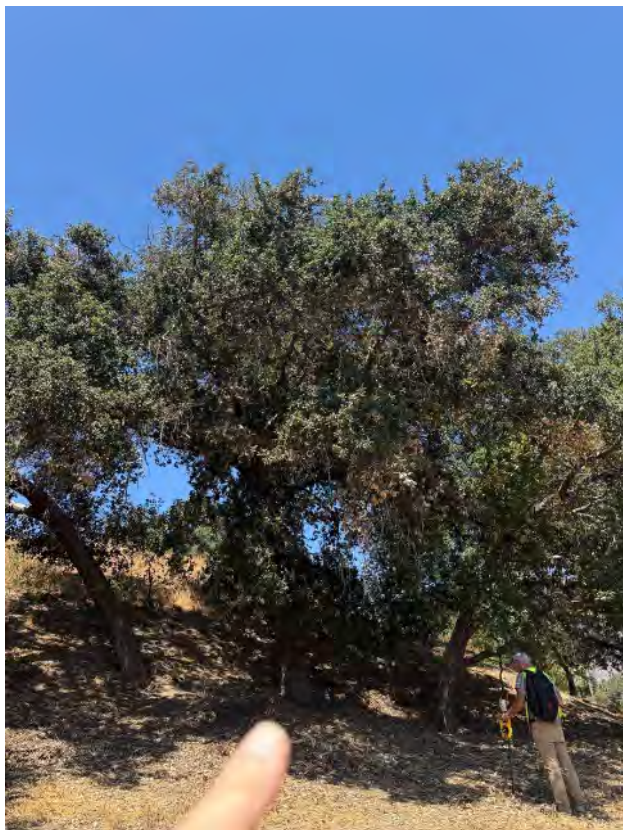
| Tree | Common Name | Scientific Name | DSH (Inches) | Ht (Feet) | Vigor | Crown (Feet) | Density | Condition Factors / Notes |
|---|---|---|---|---|---|---|---|---|
| 32 | Coast Live Oak | <i>Quercus agrifolia</i> | 24 | 47 | Normal | 28 | Normal | Leaf damage and boring insect |

Photograph: 13. TREE #32  
Species: Coast Live Oak  
Category: TRE

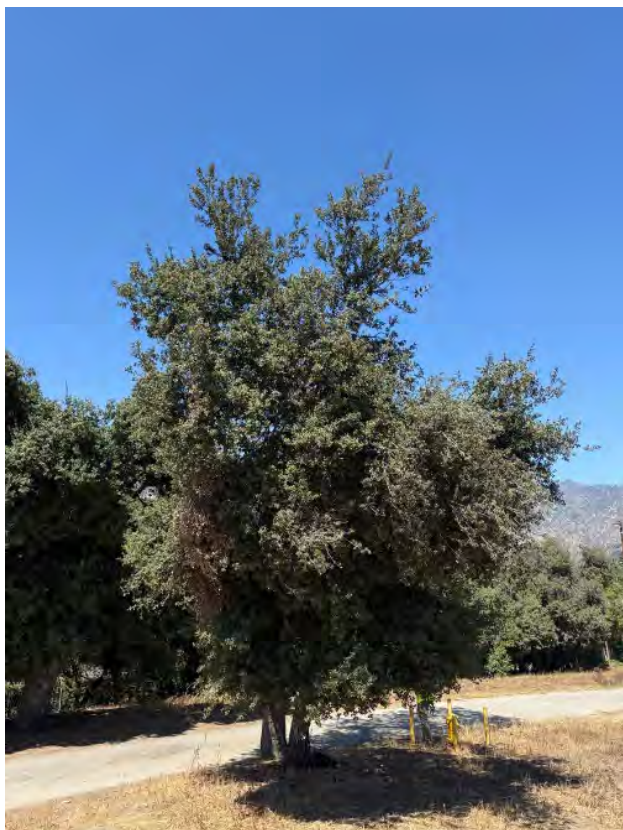
| Tree | Common Name | Scientific Name | DSH (Inches) | Ht (Feet) | Vigor | Crown (Feet) | Density | Condition Factors / Notes |
|---|---|---|---|---|---|---|---|---|
| 37 | Coast Live Oak | <i>Quercus agrifolia</i> | 12 | 18 | Normal | 17 | Normal | Leaf damage and boring insect; Lean S, all canopy S |

Photograph: 15. TREE #37  
Species: Coast Live Oak  
Category: TRE with Intensive Mitigation

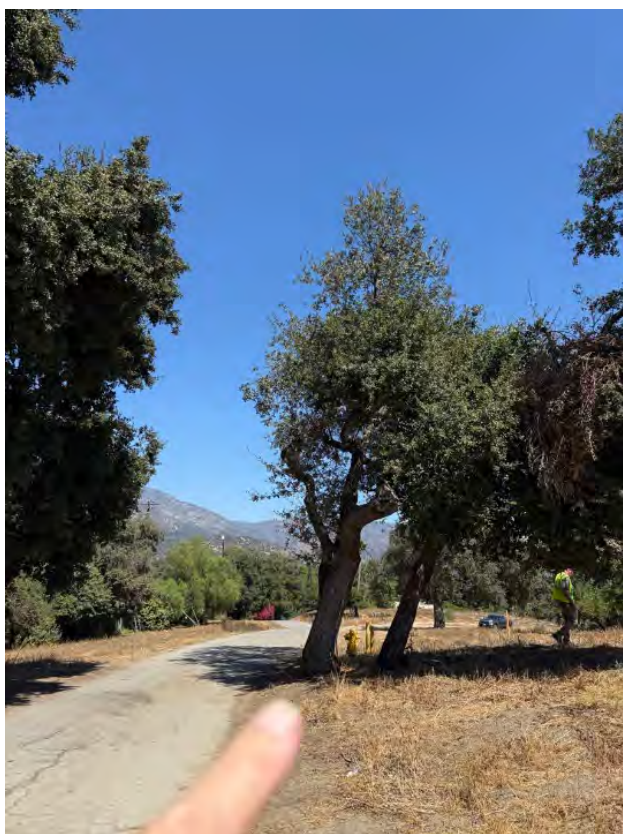
Photograph: 16. TREE #38  
Species: Engelmann Oak  
Category: TRE with Intensive Mitigation

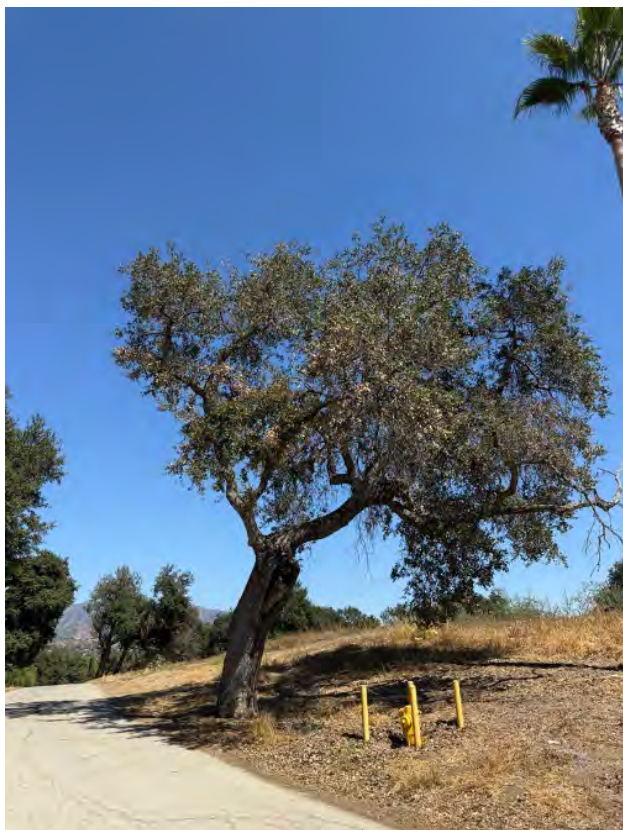
| Tree | Common Name | Scientific Name | DSH (Inches) | Ht (Feet) | Vigor | Crown (Feet) | Density | Condition Factors / Notes |
|---|---|---|---|---|---|---|---|---|
| 40 | Engelmann Oak (Mesa Oak) | <i>Quercus engelmannii</i> | 30 | 40 | Low | 33 | Sparse | Insect damage leaf and boring; Trunk damage; Some flagging directional pruning from road |

Photograph: 17. TREE #40  
Species: Engelmann Oak  
Category: TRE with Intensive Mitigation

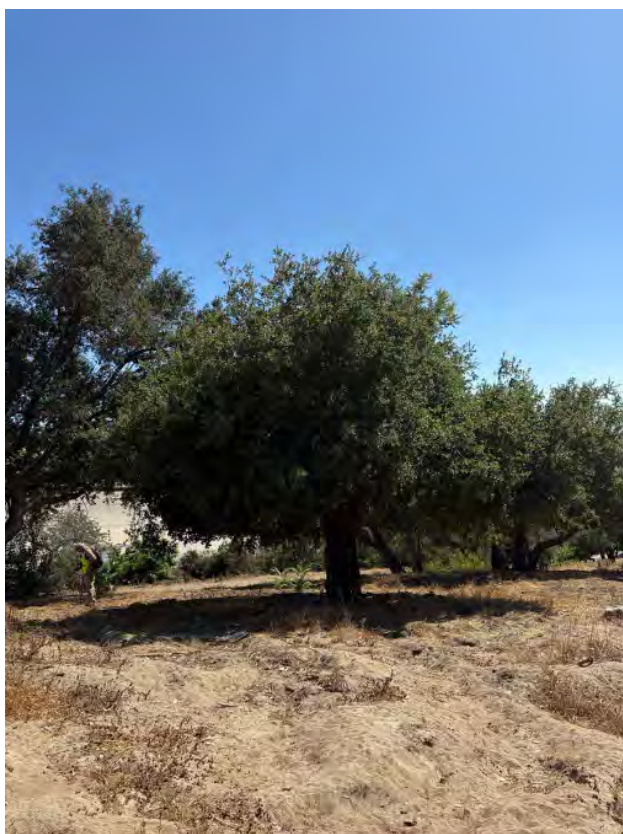
| Tree | Common Name | Scientific Name | DSH (Inches) | Ht (Feet) | Vigor | Crown (Feet) | Density | Condition Factors / Notes |
|---|---|---|---|---|---|---|---|---|
| 42 | Coast Live Oak | <i>Quercus agrifolia</i> | 27 | 23 | Low | 15 | Normal | Insect damage leaf and boring; Massive damage to the trunk and main crotch but this tree is borderline hazardous laterals |

Photograph: 18. TREE #42  
Species: Coast Live Oak  
Category: TRH

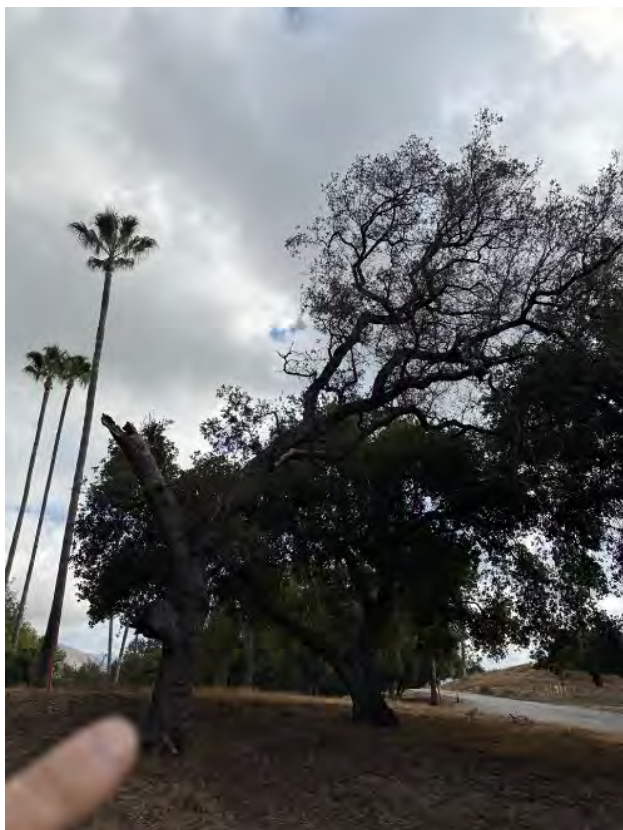
| <b>Tree</b> | <b>Common Name</b> | <b>Scientific Name</b> | <b>DSH (Inches)</b> | <b>Ht (Feet)</b> | <b>Vigor</b> | <b>Crown (Feet)</b> | <b>Density</b> | <b>Condition Factors / Notes</b> |
|---|---|---|---|---|---|---|---|---|
| 80 | Engelmann Oak (Mesa Oak) | <i>Quercus engelmannii</i> | 26 | 40 | Low | 25 | Sparse | Insect leaf damage, boring; Cavity repair on trunk, canopy SE of trunk; Looks sickly |

Photograph: 25. TREE #80  
Species: Engelmann Oak  
Category: TRE with Intensive Mitigation

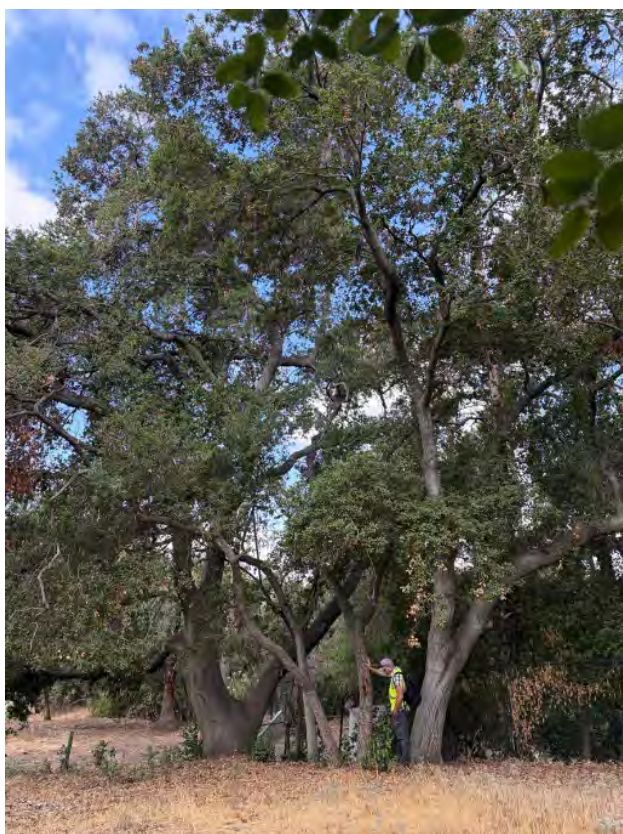
| <b>Tree</b> | <b>Common Name</b> | <b>Scientific Name</b> | <b>DSH (Inches)</b> | <b>Ht (Feet)</b> | <b>Vigor</b> | <b>Crown (Feet)</b> | <b>Density</b> | <b>Condition Factors / Notes</b> |
|---|---|---|---|---|---|---|---|---|
| 81 | Engelmann Oak (Mesa Oak) | <i>Quercus engelmannii</i> | 15 | 40 | Low | 25 | Sparse | Insect leaf damage, boring; Multistem, crowding |

Photograph: 26. TREE #81  
Species: Engelmann Oak  
Category: Protect in place, Avoid

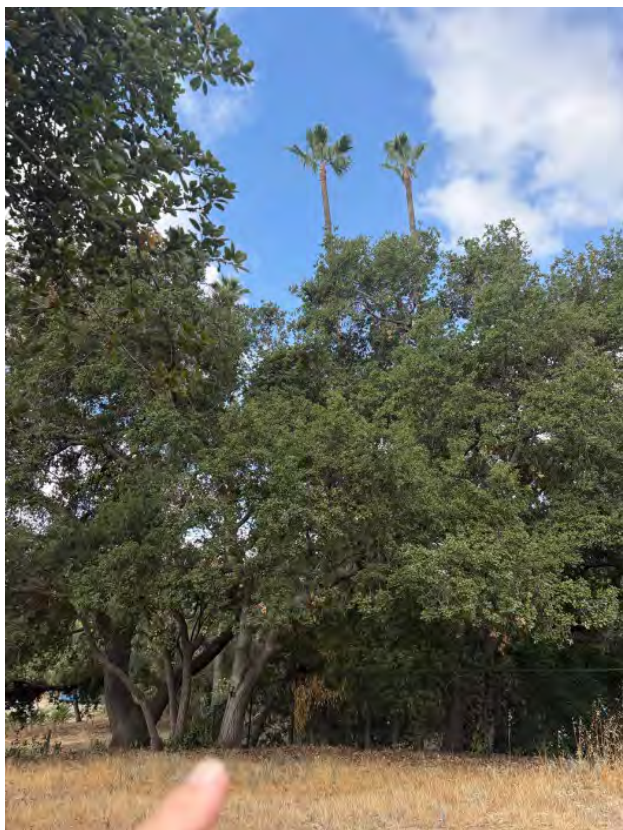
| <b>Tree</b> | <b>Common Name</b> | <b>Scientific Name</b> | <b>DSH (Inches)</b> | <b>Ht (Feet)</b> | <b>Vigor</b> | <b>Crown (Feet)</b> | <b>Density</b> | <b>Condition Factors / Notes</b> |
|---|---|---|---|---|---|---|---|---|
| 82 | Coast Live Oak | <i>Quercus agrifolia</i> | 20 | 40 | Normal | 30 | Normal | Insect leaf damage |

Photograph: 27. TREE #82  
Species: Coast Live Oak  
Category: Protect in place, Avoid

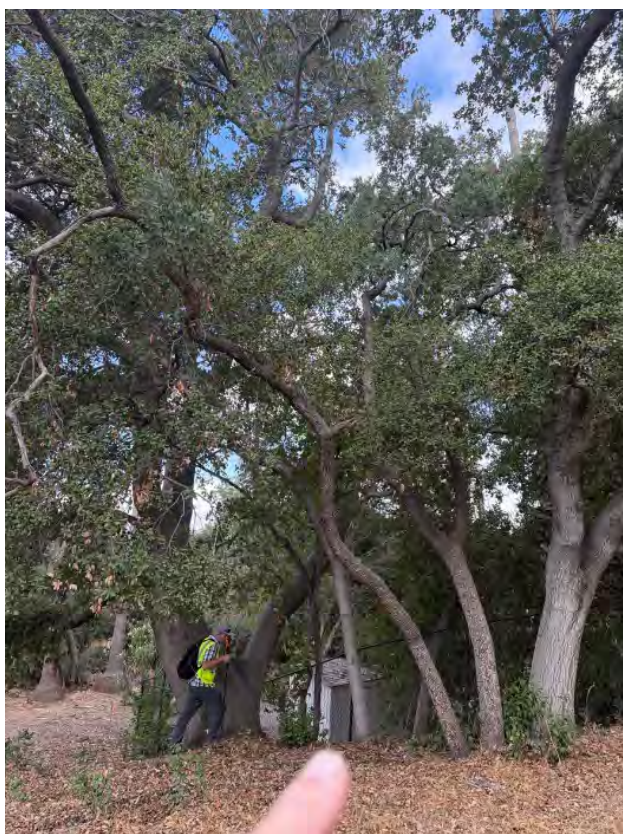
| <b>Tree</b> | <b>Common Name</b> | <b>Scientific Name</b> | <b>DSH (Inches)</b> | <b>Ht (Feet)</b> | <b>Vigor</b> | <b>Crown (Feet)</b> | <b>Density</b> | <b>Condition Factors / Notes</b> |
|---|---|---|---|---|---|---|---|---|
| 83 | Coast Live Oak | <i>Quercus agrifolia</i> | 7 | 20 | Normal | 22 | Normal | Insect leaf damage |

Photograph: 28. TREE #83  
Species: Coast Live Oak  
Category: Protect in place, Avoid

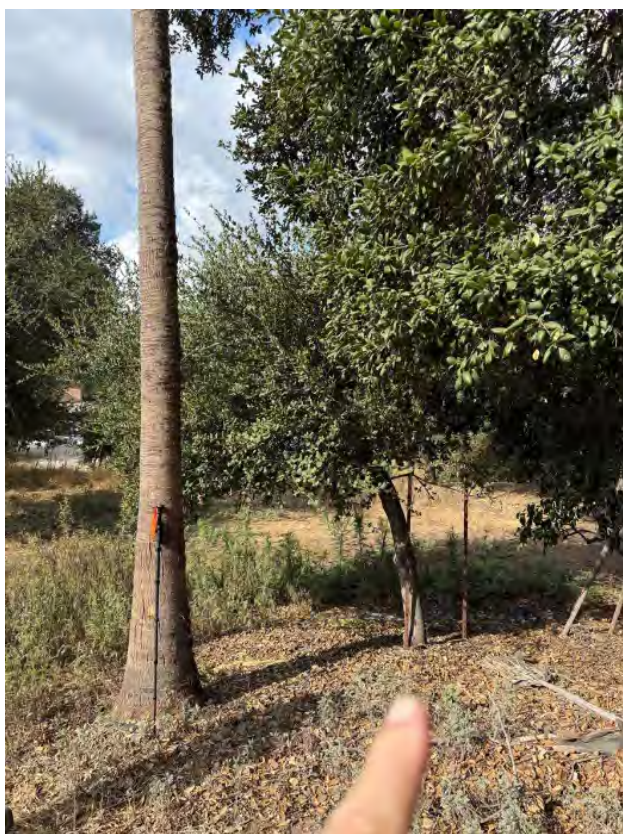
| <b>Tree</b> | <b>Common Name</b> | <b>Scientific Name</b> | <b>DSH (Inches)</b> | <b>Ht (Feet)</b> | <b>Vigor</b> | <b>Crown (Feet)</b> | <b>Density</b> | <b>Condition Factors / Notes</b> |
|---|---|---|---|---|---|---|---|---|
| 87 | Coast Live Oak | <i>Quercus agrifolia</i> | 6 | 15 | Normal | 11 | Normal | Insect leaf damage; Lean SE |

Photograph: 30. TREE #87  
Species: Coast Live Oak  
Category: TRH

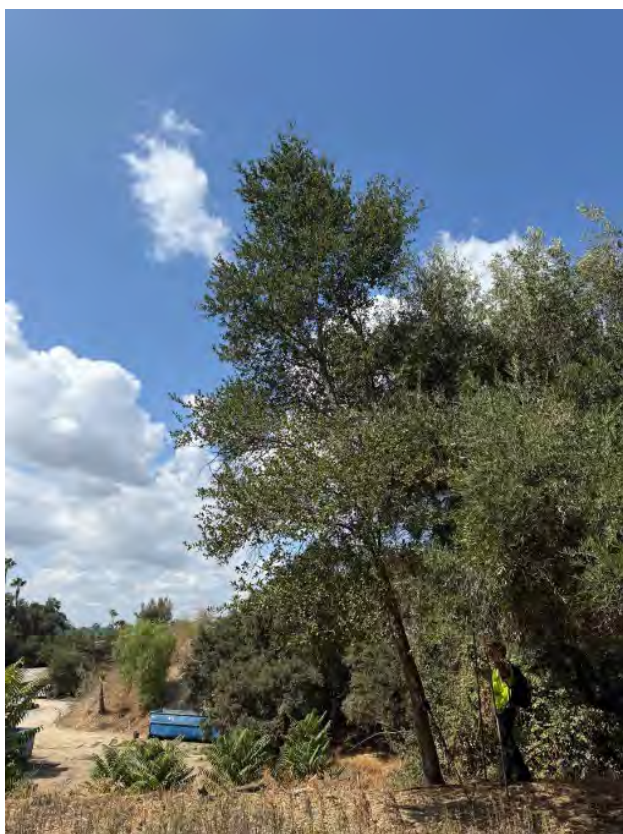
| <b>Tree</b> | <b>Common Name</b> | <b>Scientific Name</b> | <b>DSH (Inches)</b> | <b>Ht (Feet)</b> | <b>Vigor</b> | <b>Crown (Feet)</b> | <b>Density</b> | <b>Condition Factors / Notes</b> |
|---|---|---|---|---|---|---|---|---|
| 109 | Coast Live Oak | <i>Quercus agrifolia</i> | 8 | 30 | Normal | 10 | Normal | Insect leaf damage; Lean SE |

Photograph: 32. TREE # 109  
Species: Coast Live Oak  
Category: TRH

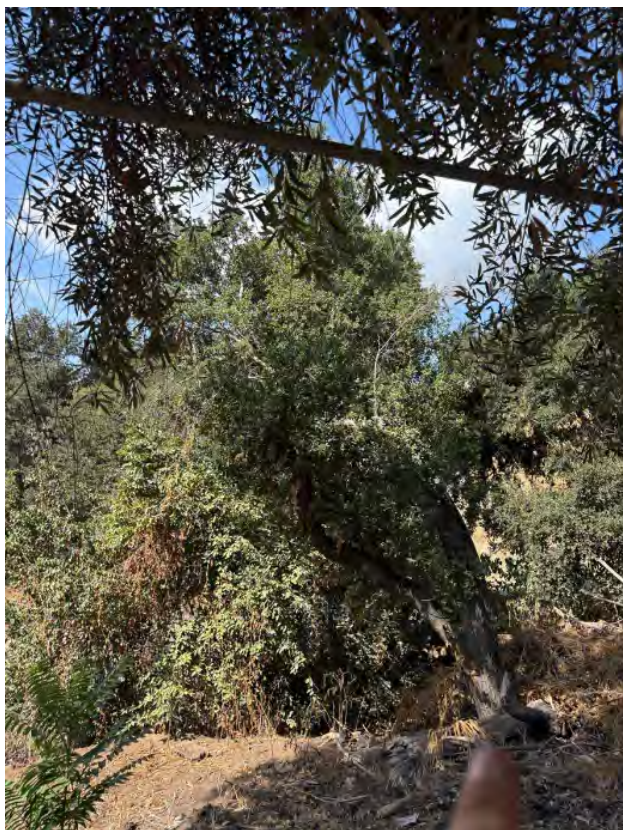
| <b>Tree</b> | <b>Common Name</b> | <b>Scientific Name</b> | <b>DSH (Inches)</b> | <b>Ht (Feet)</b> | <b>Vigor</b> | <b>Crown (Feet)</b> | <b>Density</b> | <b>Condition Factors / Notes</b> |
|---|---|---|---|---|---|---|---|---|
| 110 | Coast Live Oak | <i>Quercus agrifolia</i> | 17 | 25 | Normal | 25 | Normal | Insect leaf damage, boring; Significant lean SW, trunk damage |

Photograph: 33. TREE #110  
Species: Coast Live Oak  
Category: TRE

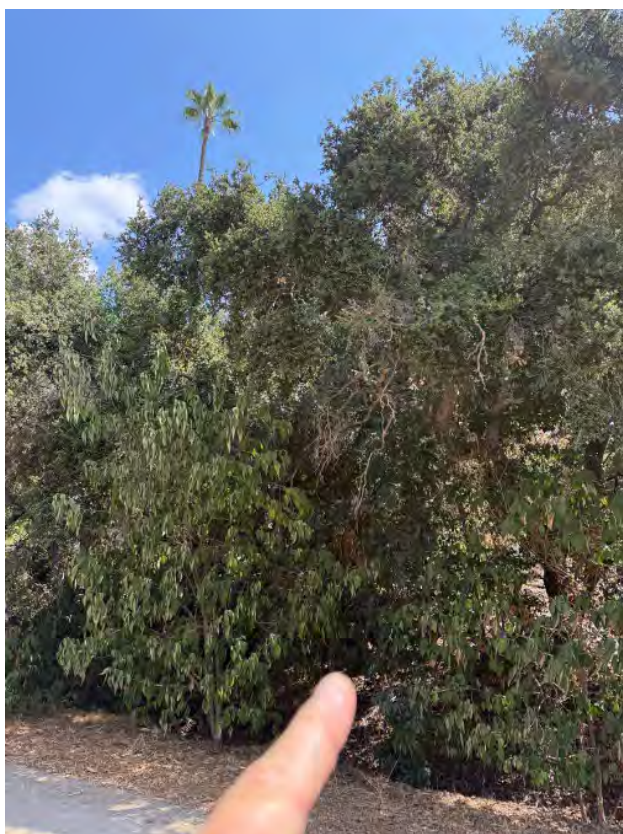
| <b>Tree</b> | <b>Common Name</b> | <b>Scientific Name</b> | <b>DSH (Inches)</b> | <b>Ht (Feet)</b> | <b>Vigor</b> | <b>Crown (Feet)</b> | <b>Density</b> | <b>Condition Factors / Notes</b> |
|---|---|---|---|---|---|---|---|---|
| 115 | Coast Live Oak | <i>Quercus agrifolia</i> | 30 | 40 | Normal | 40 | Normal | Insect leaf damage, boring; Dead laterals |

Photograph: 34. TREE #115  
Species: Coast Live Oak  
Category: TRE

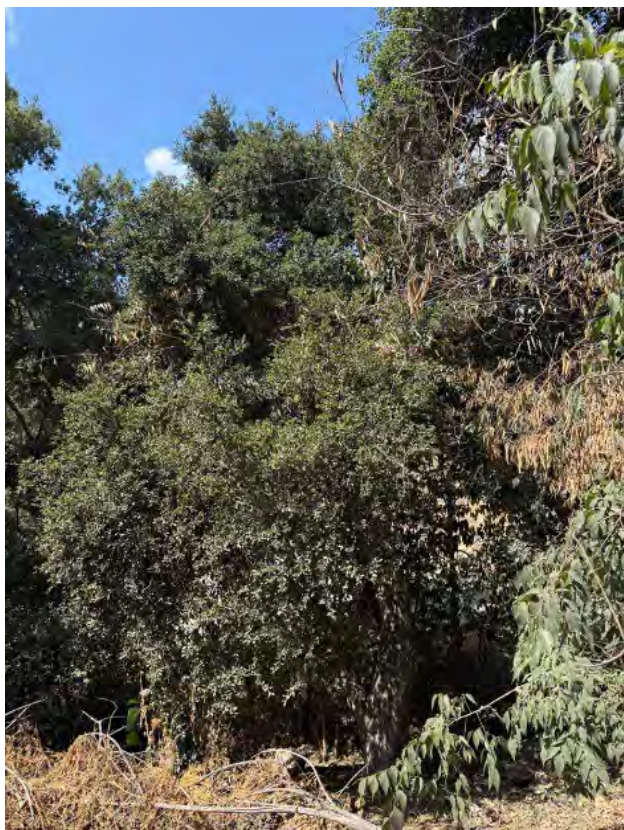
| <b>Tree</b> | <b>Common Name</b> | <b>Scientific Name</b> | <b>DSH (Inches)</b> | <b>Ht (Feet)</b> | <b>Vigor</b> | <b>Crown (Feet)</b> | <b>Density</b> | <b>Condition Factors / Notes</b> |
|---|---|---|---|---|---|---|---|---|
| 116 | Coast Live Oak | <i>Quercus agrifolia</i> | 42 | 40 | Normal | 30 | Normal | Insect leaf damage; Multistem, lean W canopy W, |

Photograph: 35. TREE #116  
Species: Coast Live Oak  
Category: TRE

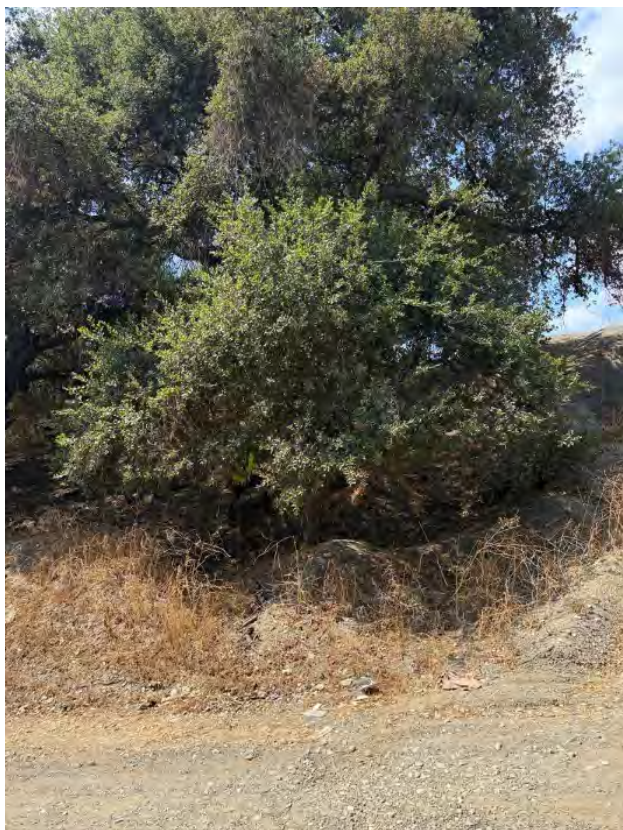
| <b>Tree</b> | <b>Common Name</b> | <b>Scientific Name</b> | <b>DSH (Inches)</b> | <b>Ht (Feet)</b> | <b>Vigor</b> | <b>Crown (Feet)</b> | <b>Density</b> | <b>Condition Factors / Notes</b> |
|---|---|---|---|---|---|---|---|---|
| 122 | Coast Live Oak | <i>Quercus agrifolia</i> | 10 | 15 | Normal | 12 | Sparse | Insect leaf damage, boring; Multistem, |

Photograph: 39. TREE # 122  
Species: Coast Live Oak  
Category: TRH

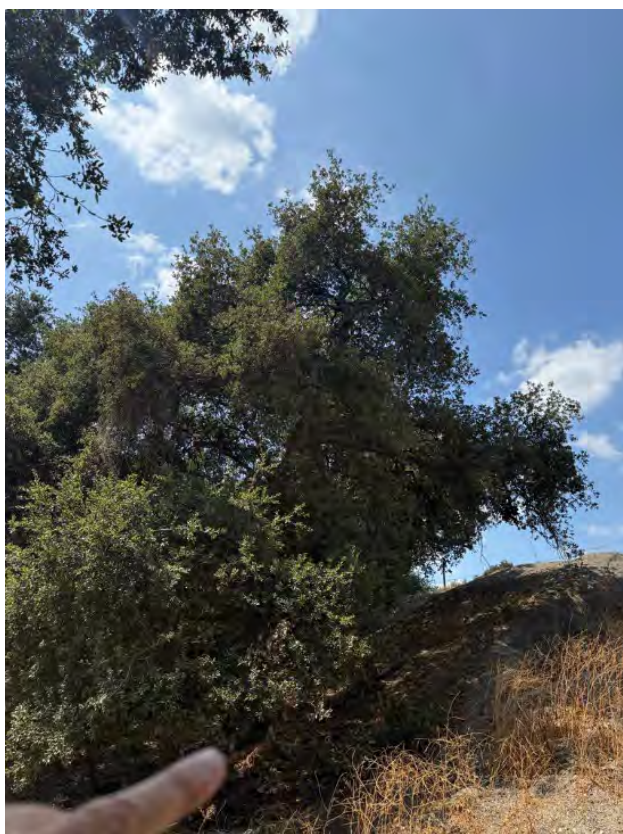
| <b>Tree</b> | <b>Common Name</b> | <b>Scientific Name</b> | <b>DSH (Inches)</b> | <b>Ht (Feet)</b> | <b>Vigor</b> | <b>Crown (Feet)</b> | <b>Density</b> | <b>Condition Factors / Notes</b> |
|---|---|---|---|---|---|---|---|---|
| 123 | Coast Live Oak | <i>Quercus agrifolia</i> | 28 | 45 | Normal | 30 | Normal | Insect leaf damage |

Photograph: 40. TREE #123  
Species: Coast Live Oak  
Category: TRH

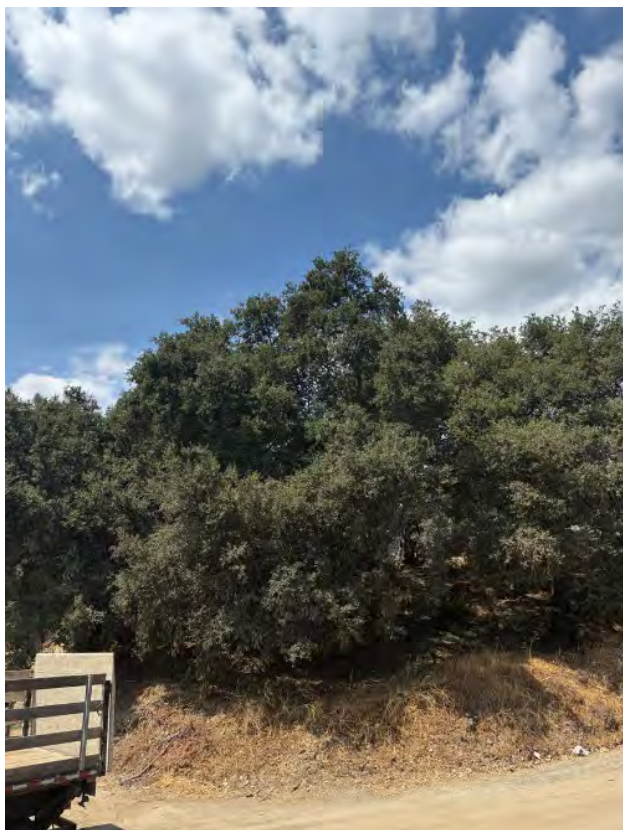
| <b>Tree</b> | <b>Common Name</b> | <b>Scientific Name</b> | <b>DSH (Inches)</b> | <b>Ht (Feet)</b> | <b>Vigor</b> | <b>Crown (Feet)</b> | <b>Density</b> | <b>Condition Factors / Notes</b> |
|---|---|---|---|---|---|---|---|---|
| 124 | Coast Live Oak | <i>Quercus agrifolia</i> | 57 | 48 | Normal | 40 | Normal | Insect leaf damage; DBH measure at base below crotch |

Photograph: 41. TREE # 124  
Species: Coast Live Oak  
Category: TRH

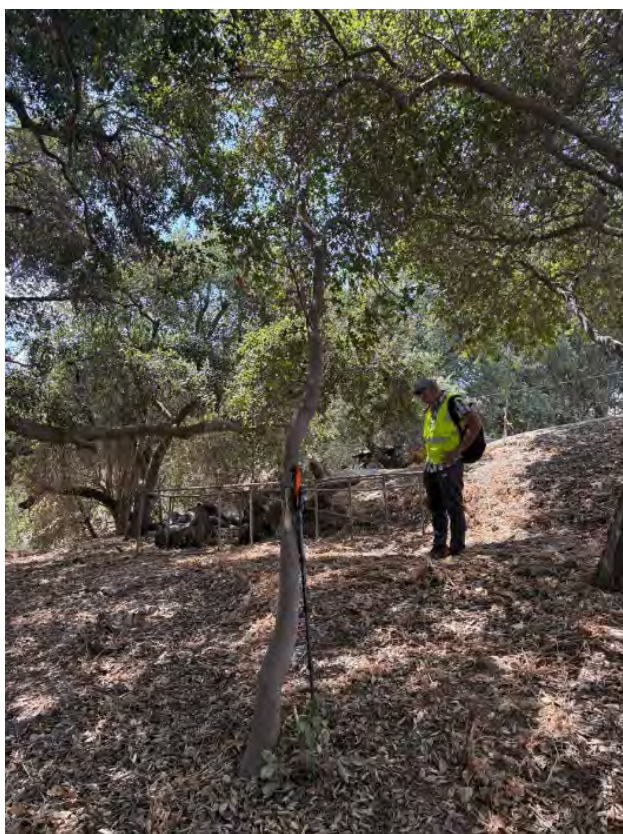
| <b>Tree</b> | <b>Common Name</b> | <b>Scientific Name</b> | <b>DSH (Inches)</b> | <b>Ht (Feet)</b> | <b>Vigor</b> | <b>Crown (Feet)</b> | <b>Density</b> | <b>Condition Factors / Notes</b> |
|---|---|---|---|---|---|---|---|---|
| 126 | Coast Live Oak | <i>Quercus agrifolia</i> | 4 | 17 | Normal | 10 | Normal | Insect leaf damage; Lean S; |

Photograph: 42. TREE #126  
Species: Coast Live Oak  
Category: TRH

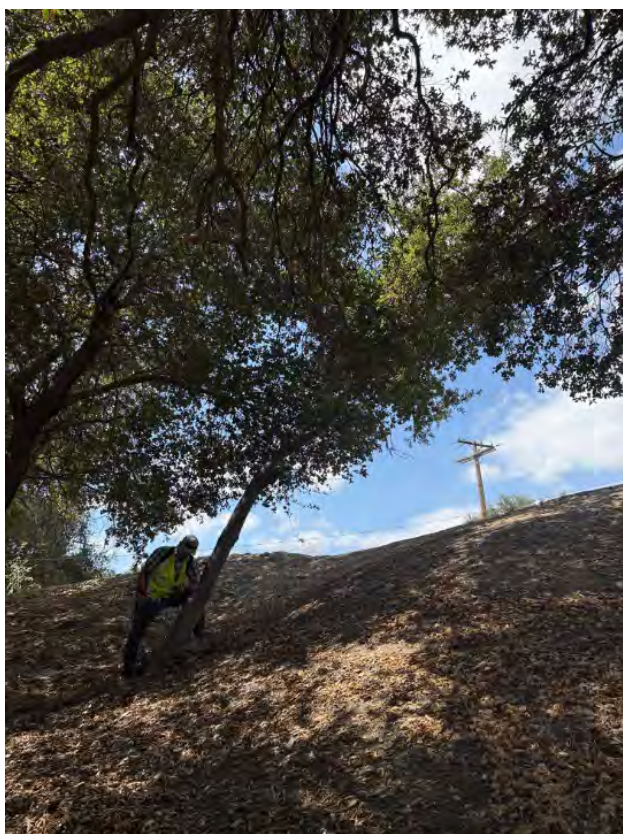
| <b>Tree</b> | <b>Common Name</b> | <b>Scientific Name</b> | <b>DSH (Inches)</b> | <b>Ht (Feet)</b> | <b>Vigor</b> | <b>Crown (Feet)</b> | <b>Density</b> | <b>Condition Factors / Notes</b> |
|---|---|---|---|---|---|---|---|---|
| 128 | Coast Live Oak | <i>Quercus agrifolia</i> | 8 | 23 | Normal | 12 | Normal | Insect leaf damage; Lean N heavy |

Photograph: 44. TREE #128  
Species: Coast Live Oak  
Category: TRH

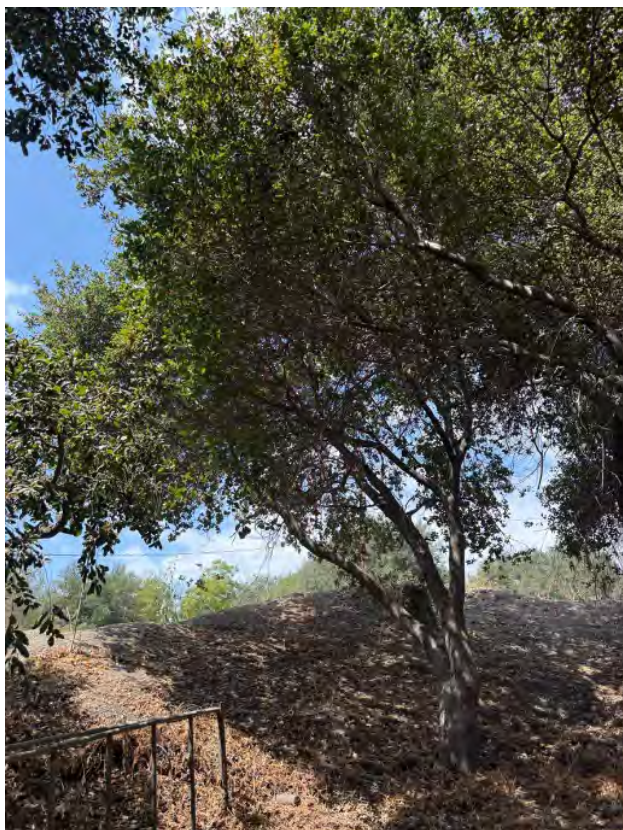
| <b>Tree</b> | <b>Common Name</b> | <b>Scientific Name</b> | <b>DSH (Inches)</b> | <b>Ht (Feet)</b> | <b>Vigor</b> | <b>Crown (Feet)</b> | <b>Density</b> | <b>Condition Factors / Notes</b> |
|---|---|---|---|---|---|---|---|---|
| 129 | Coast Live Oak | <i>Quercus agrifolia</i> | 17 | 20 | Normal | 15 | Normal | Insect leaf damage; Included bark; Growth NW |

Photograph: 45. TREE #129  
Species: Coast Live Oak  
Category: TRH

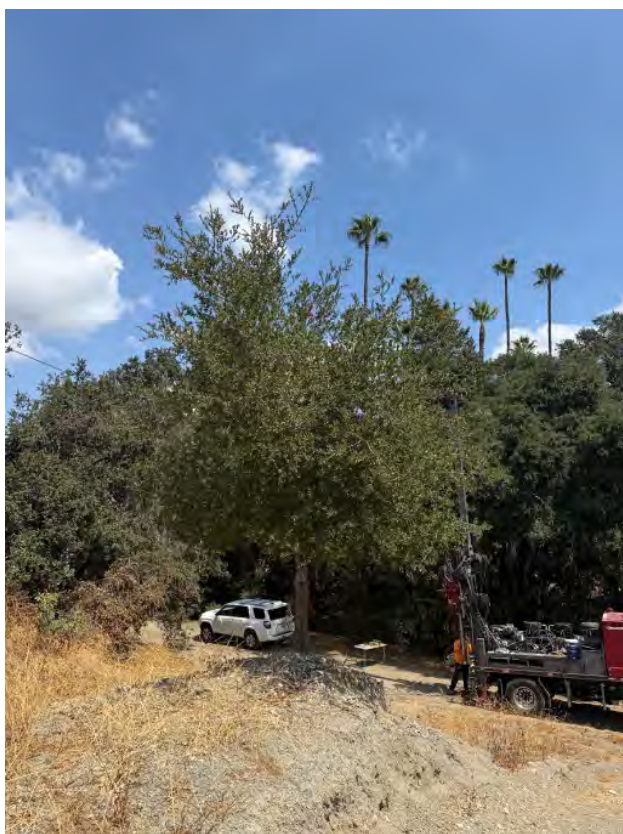
| <b>Tree</b> | <b>Common Name</b> | <b>Scientific Name</b> | <b>DSH (Inches)</b> | <b>Ht (Feet)</b> | <b>Vigor</b> | <b>Crown (Feet)</b> | <b>Density</b> | <b>Condition Factors / Notes</b> |
|---|---|---|---|---|---|---|---|---|
| 130 | Coast Live Oak | <i>Quercus agrifolia</i> | 6 | 15 | Normal | 9 | Normal | Insect leaf damage |

Photograph: 46. TREE # 130  
Species: Coast Live Oak  
Category: TRH

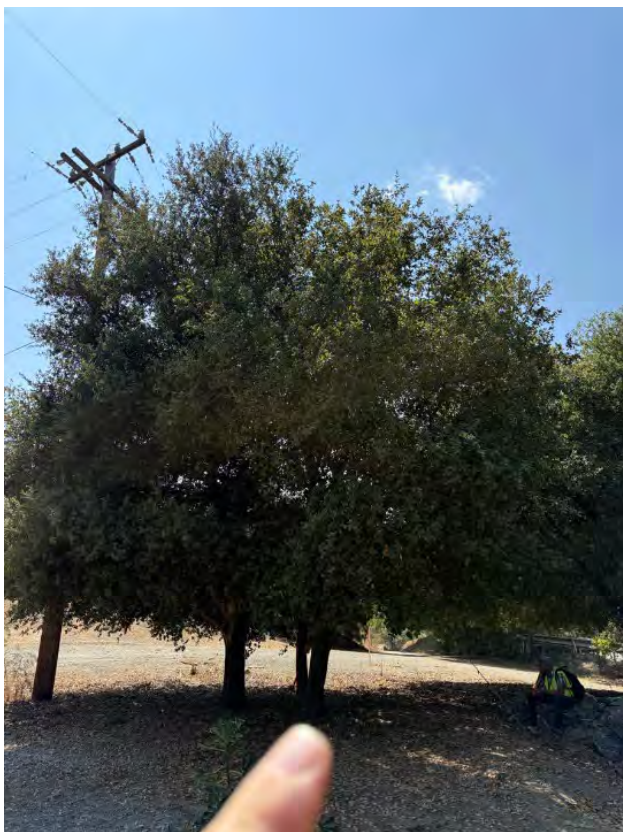
| Tree | Common Name | Scientific Name | DSH (Inches) | Ht (Feet) | Vigor | Crown (Feet) | Density | Condition Factors / Notes |
|---|---|---|---|---|---|---|---|---|
| 136 | Coast Live Oak | <i>Quercus agrifolia</i> | 20 | 28 | Normal | 15 | Normal | Insect leaf damage; Bark inclusion; Multistem |

Photograph: 48. TREE #136  
Species: Coast Live Oak  
Category: TRE

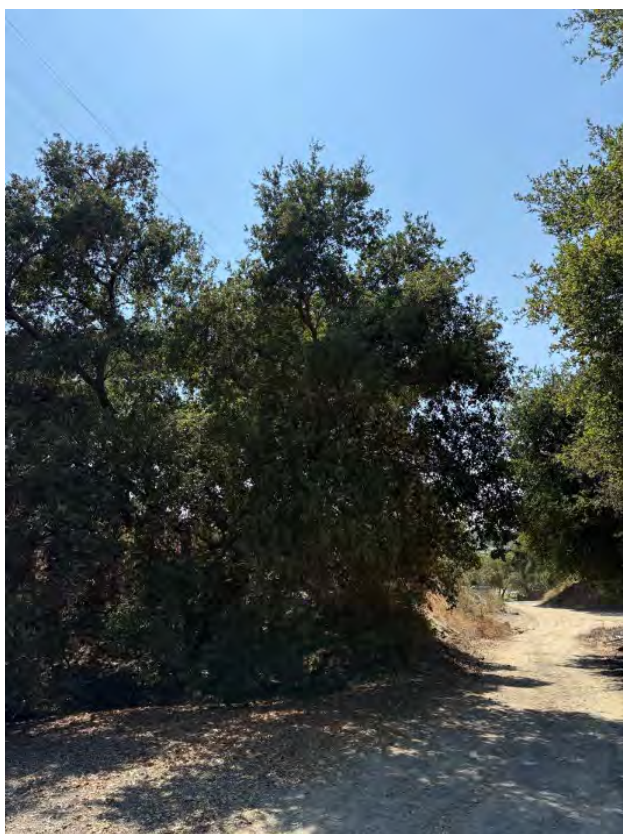
| Tree | Common Name | Scientific Name | DSH (Inches) | Ht (Feet) | Vigor | Crown (Feet) | Density | Condition Factors / Notes |
|---|---|---|---|---|---|---|---|---|
| 144 | Coast Live Oak | <i>Quercus agrifolia</i> | 25 | 40 | Normal | 34 | Normal | Insect leaf damage; Measure below crotch |

Photograph: 50. TREE #144  
Species: Coast Live Oak  
Category: TRH

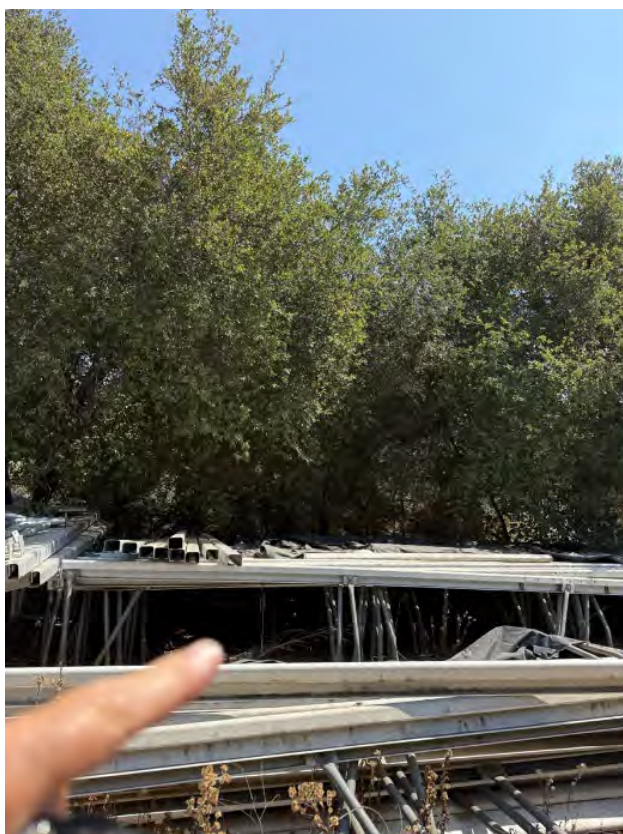
| Tree | Common Name | Scientific Name | DSH (Inches) | Ht (Feet) | Vigor | Crown (Feet) | Density | Condition Factors / Notes |
|---|---|---|---|---|---|---|---|---|
| 150 | Coast Live Oak | <i>Quercus agrifolia</i> | 10 | 30 | Normal | 15 | Normal | Insect leaf damage; Growing against fence |

Photograph: 52. TREE #150  
Species: Coast Live Oak  
Category: TRH

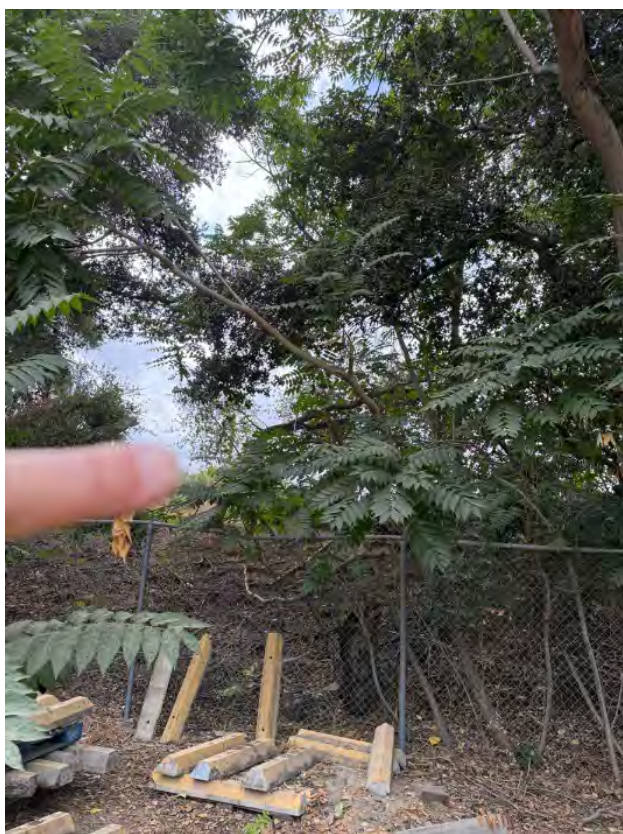
| Tree | Common Name | Scientific Name | DSH (Inches) | Ht (Feet) | Vigor | Crown (Feet) | Density | Condition Factors / Notes |
|---|---|---|---|---|---|---|---|---|
| 199 | Coast Live Oak | <i>Quercus agrifolia</i> | 9 | 20 | Low | 20 | Normal | Insect damage leaf; Lean and growth W |

Photograph: 54. TREE #199  
Species: Coast Live Oak  
Category: Protect in place, Avoid

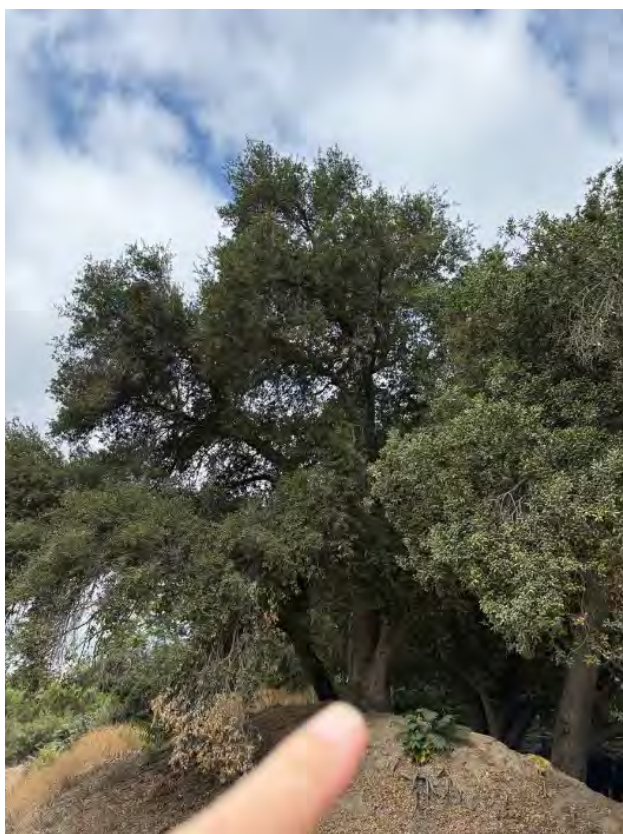
| Tree | Common Name | Scientific Name | DSH (Inches) | Ht (Feet) | Vigor | Crown (Feet) | Density | Condition Factors / Notes |
|---|---|---|---|---|---|---|---|---|
| 205 | Coast Live Oak | <i>Quercus agrifolia</i> | 35 | 35 | Normal | 25 | Normal | Insect damage leaf; Multistem |

Photograph: 58. TREE #205  
Species: Coast Live Oak  
Category: TRE with Intensive Mitigation

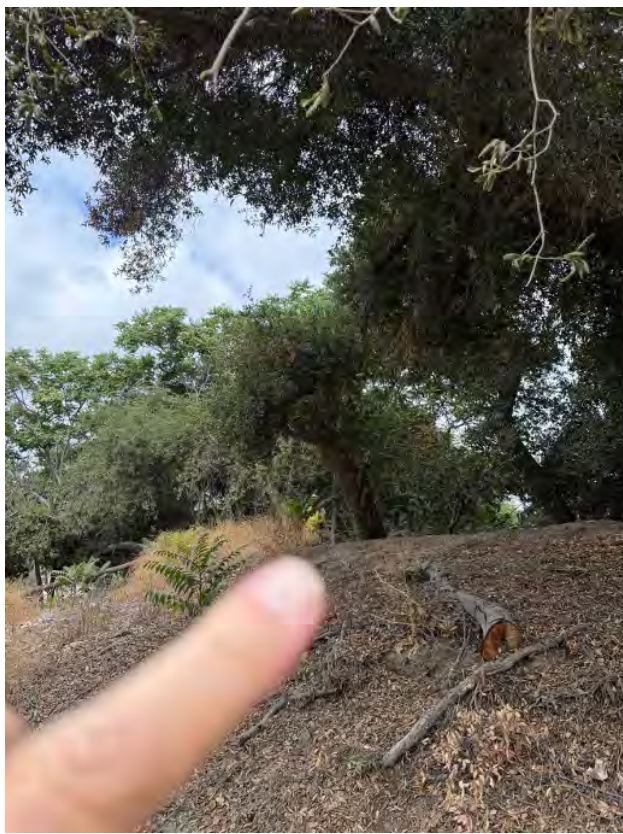
Photograph: 59. TREE 206  
Species: Coast Live Oak  
Category: TRE

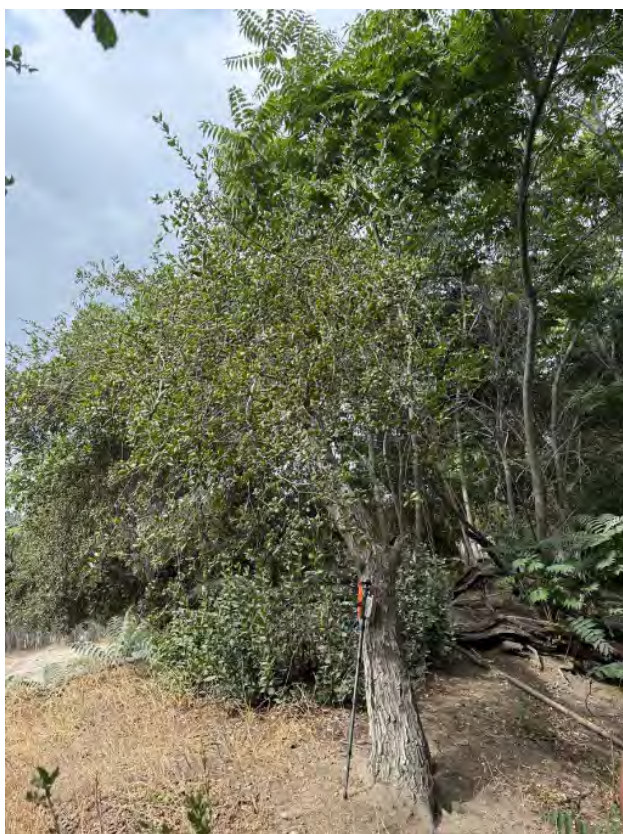
Photograph: 60. TREE #207  
Species: Coast Live Oak  
Category: TRE with Intensive Mitigation
