# **Protected Tree Assessment and Arborist Inventory Report LA28 Equestrian Course Grading Plan**

## **Prepared for**

Los Angeles Turf Club  
285 W Huntington Drive  
Arcadia, CA 91107  
Contact: Ms. Nicola Boon  
Phone: (760) 213 0963  
Email: niciboon@nbicassociates.com

June 2026

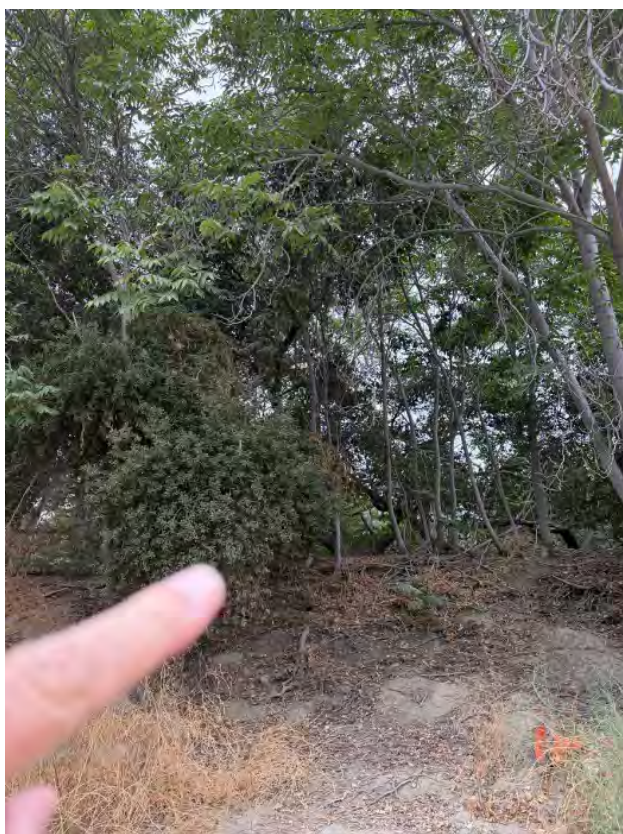
Photograph: 62. TREE #209  
Species: Coast Live Oak  
Category: Protect in place, Avoid

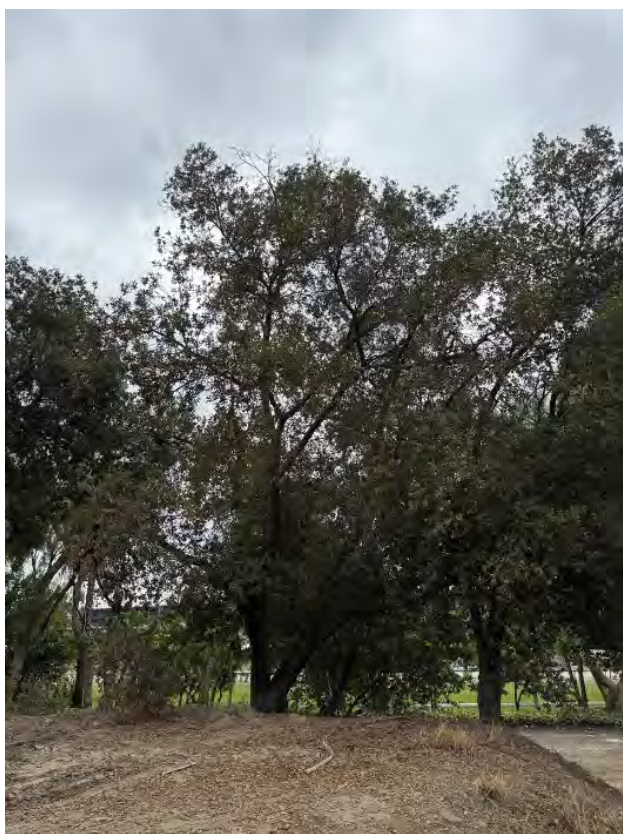
Photograph: 64. TREE #219  
Species: Coast Live Oak  
Category: Protect in place, Avoid

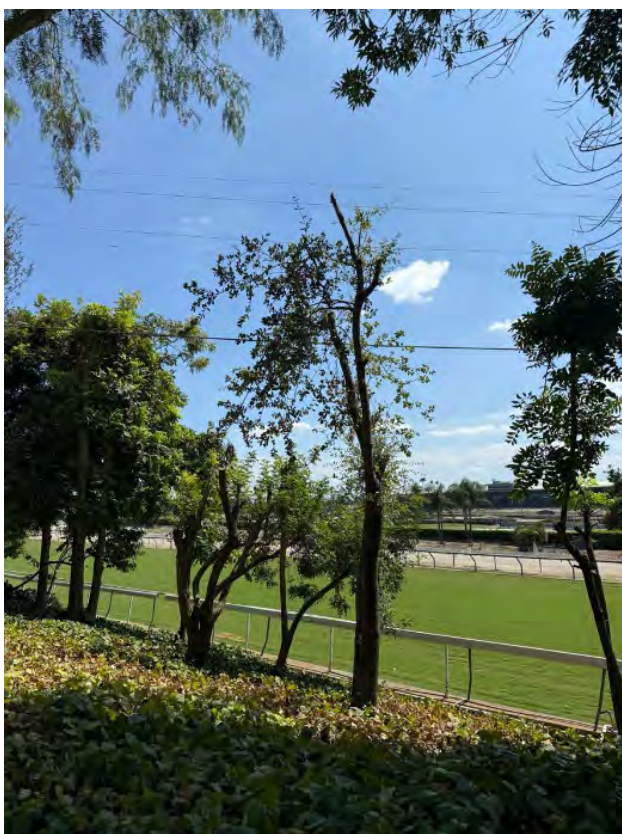
Photograph: 66. TREE #256  
Species: Coast Live Oak  
Category: TRH

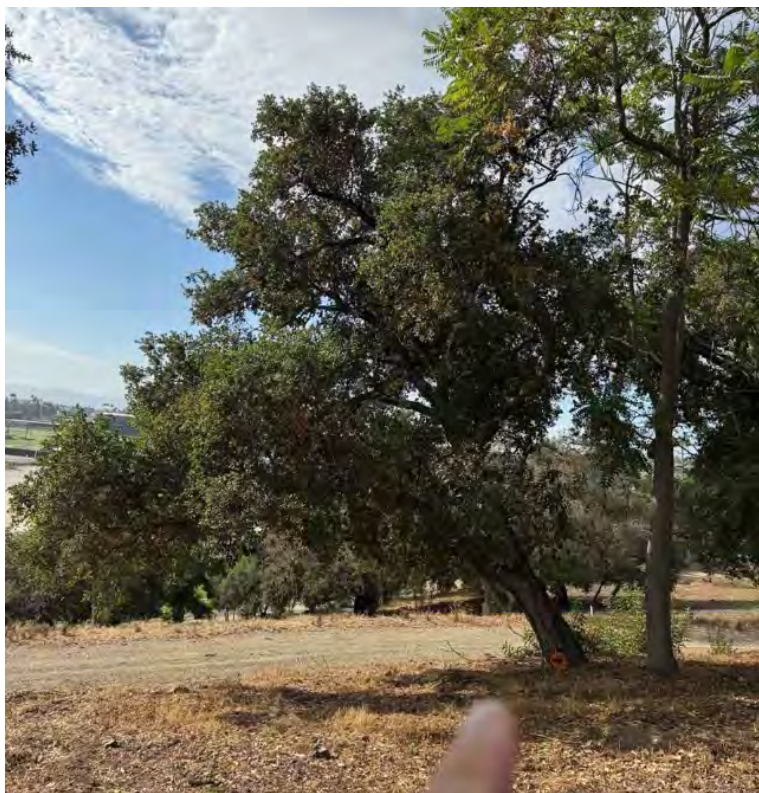
Photograph: 69. TREE #292  
Species: Coast Live Oak  
Category: TRE

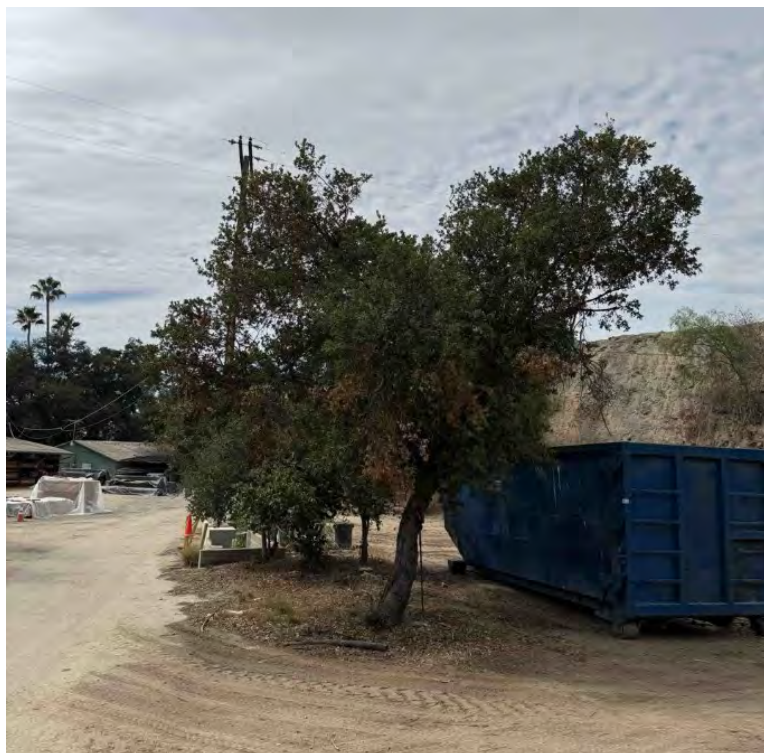
Photograph: 70. TREE #314  
Species: Coast Live Oak  
Category: Protect in place, Avoid

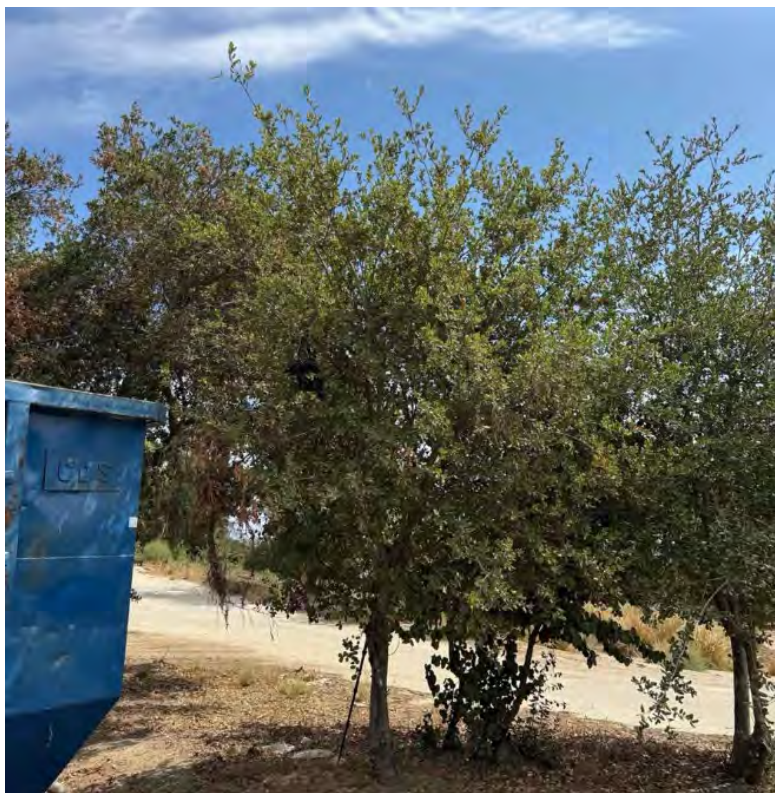
Photograph: 71. TREE #315  
Species: Coast Live Oak  
Category: TRE

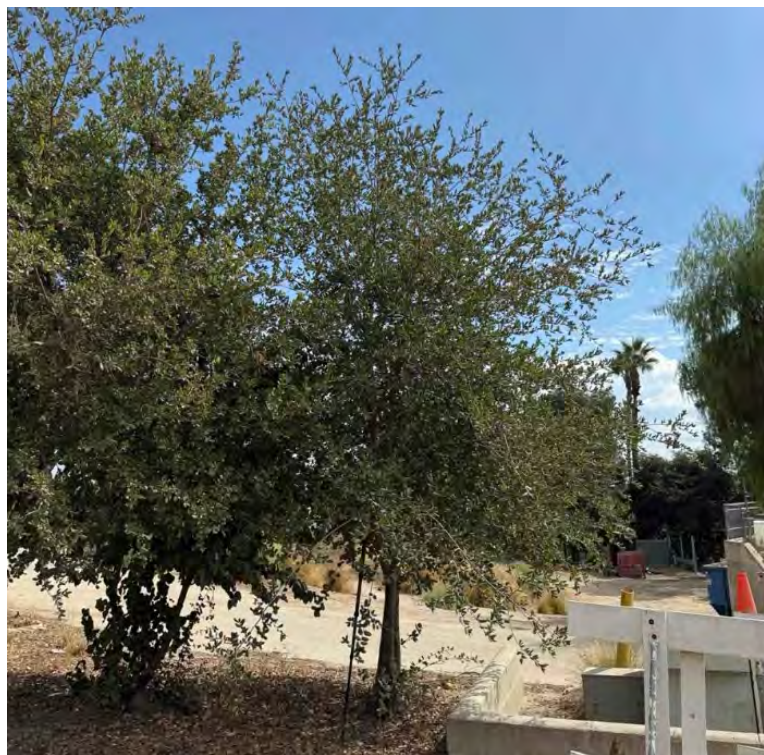
Photograph: 72. TREE #316  
Species: Coast Live Oak  
Category: TRE

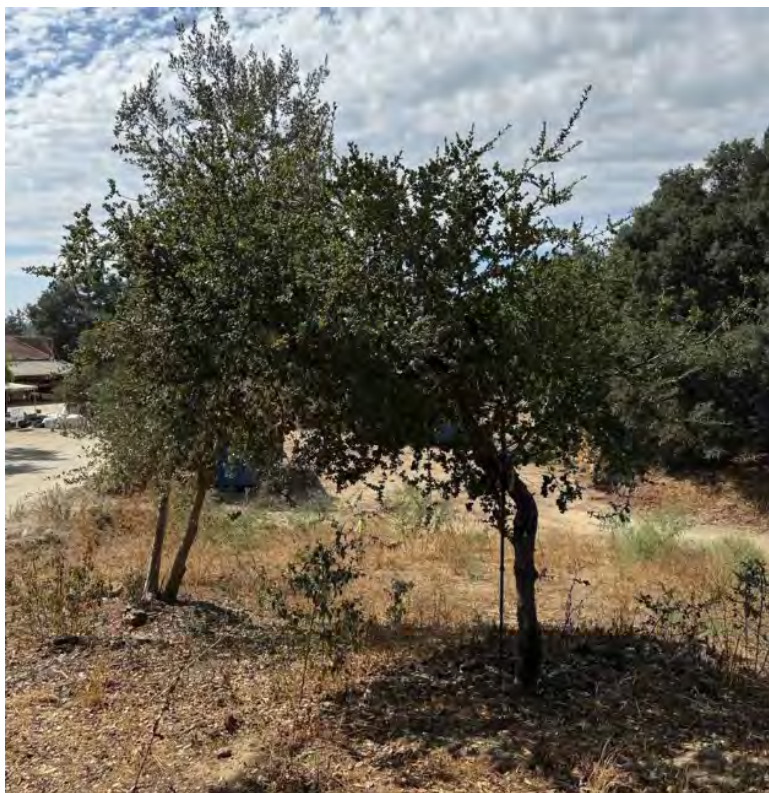
Photograph: 73. TREE #318  
Species: Coast Live Oak  
Category: TRH

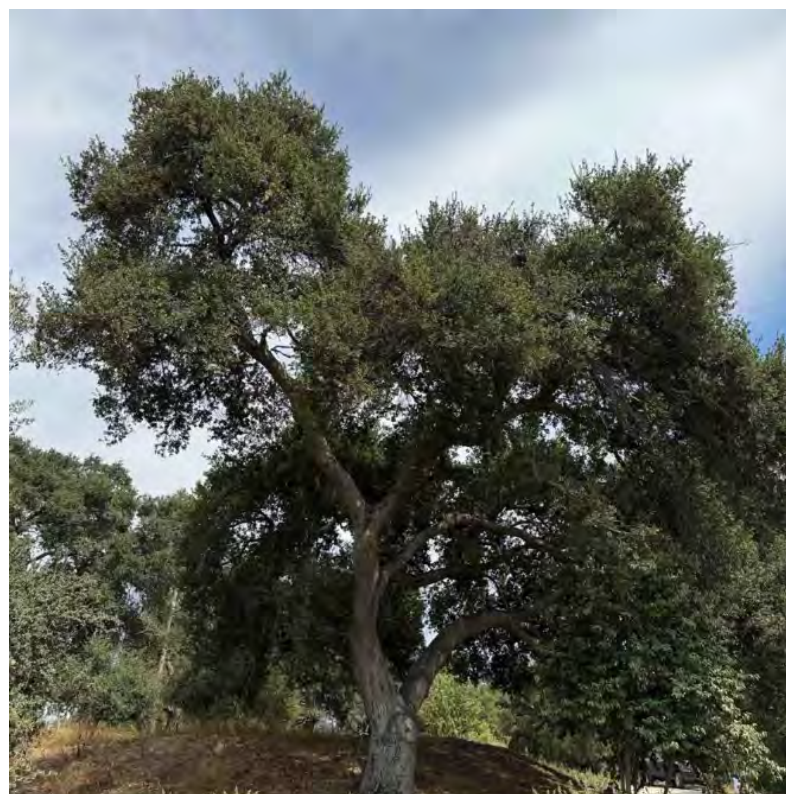
Photograph: 74. TREE #320  
Species: Coast Live Oak  
Category: TRH

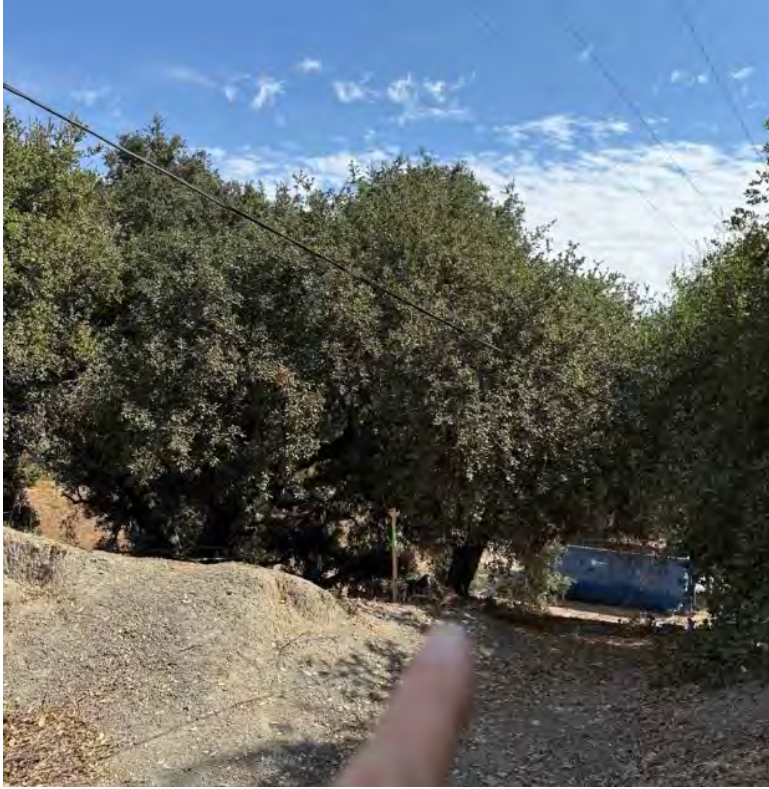
Photograph: 75. TREE #323  
Species: Coast Live Oak  
Category: TRE

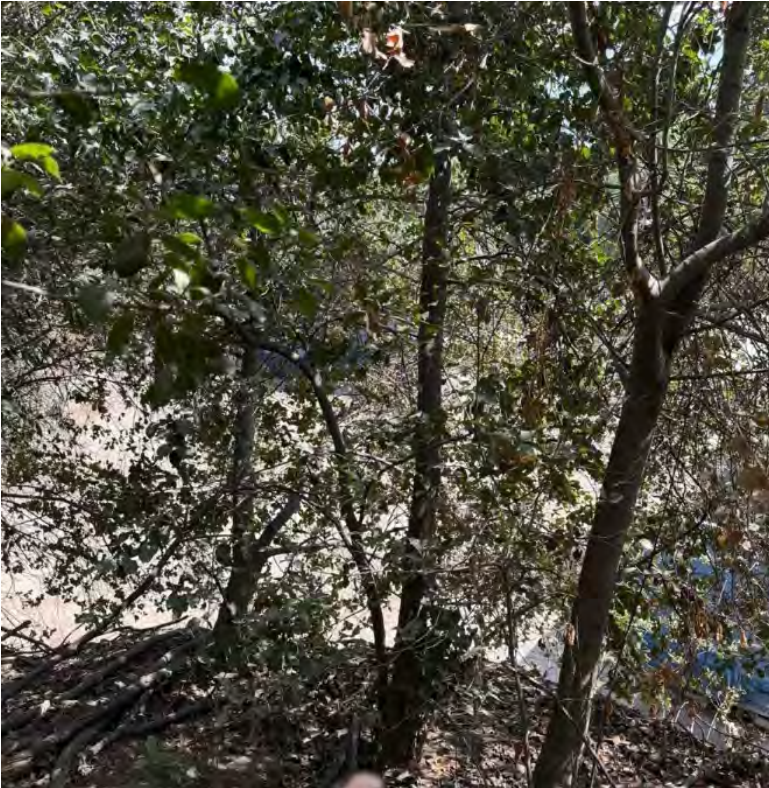
Photograph: 76. TREE #327  
Species: Coast Live Oak  
Category: TRH

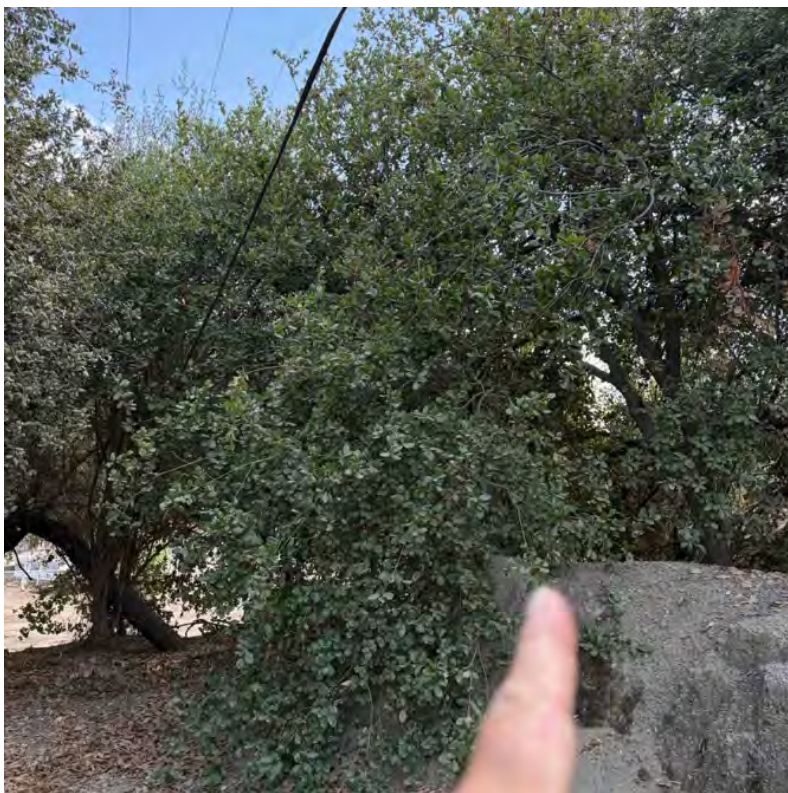
Photograph: 77. TREE #331  
Species: Coast Live Oak  
Category: TRE with Intensive Mitigation

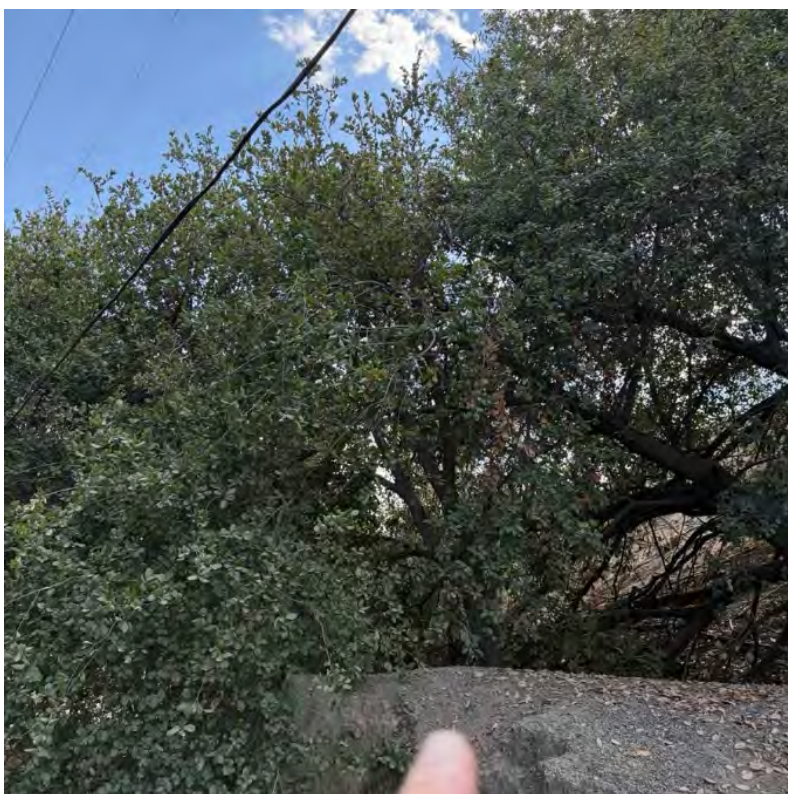
Photograph: 78. TREE #332  
Species: Coast Live Oak  
Category: TRH

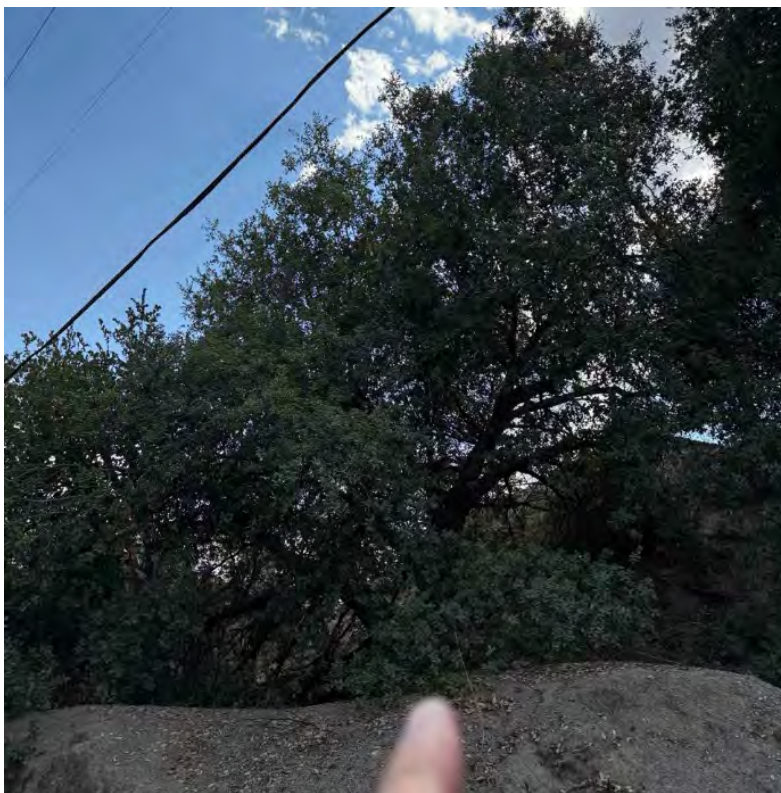
Photograph: 79. TREE #333  
Species: Coast Live Oak  
Category: TRE with Intensive Mitigation

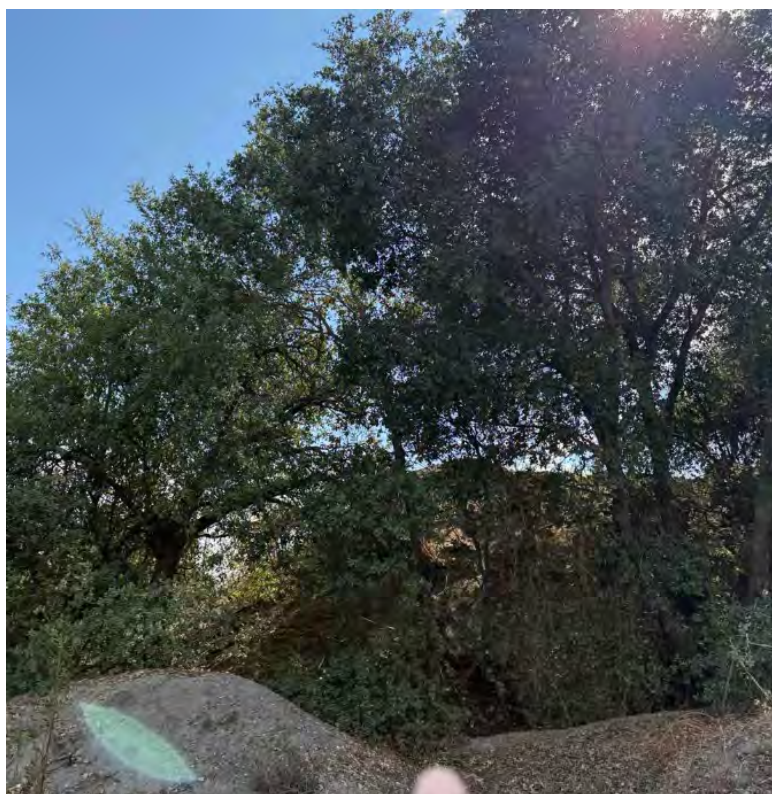
Photograph: 80. TREE #334  
Species: Coast Live Oak  
Category: TRE

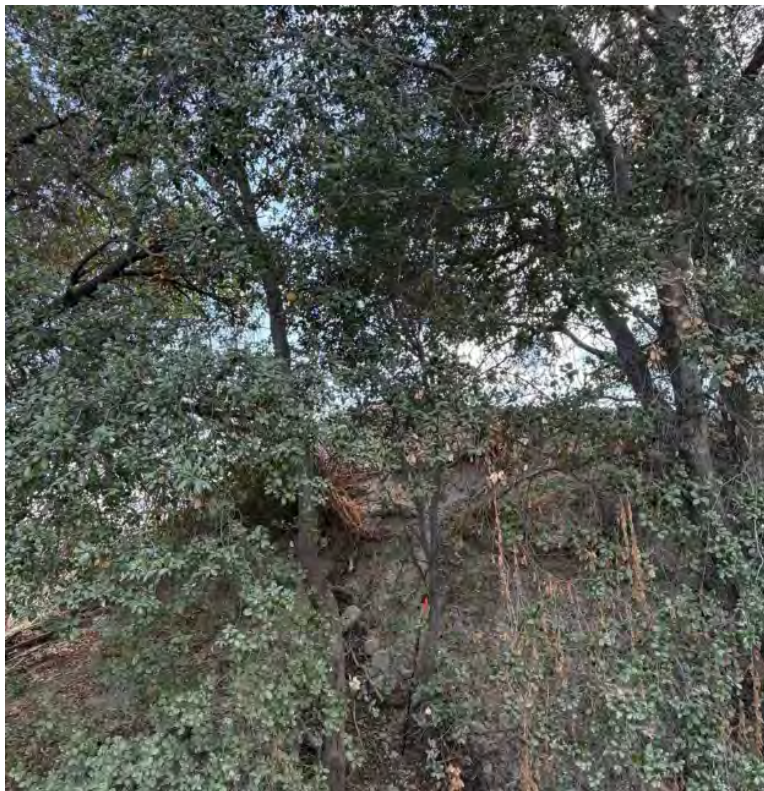
Photograph: 81. TREE #335  
Species: Coast Live Oak  
Category: Protect in place, Avoid

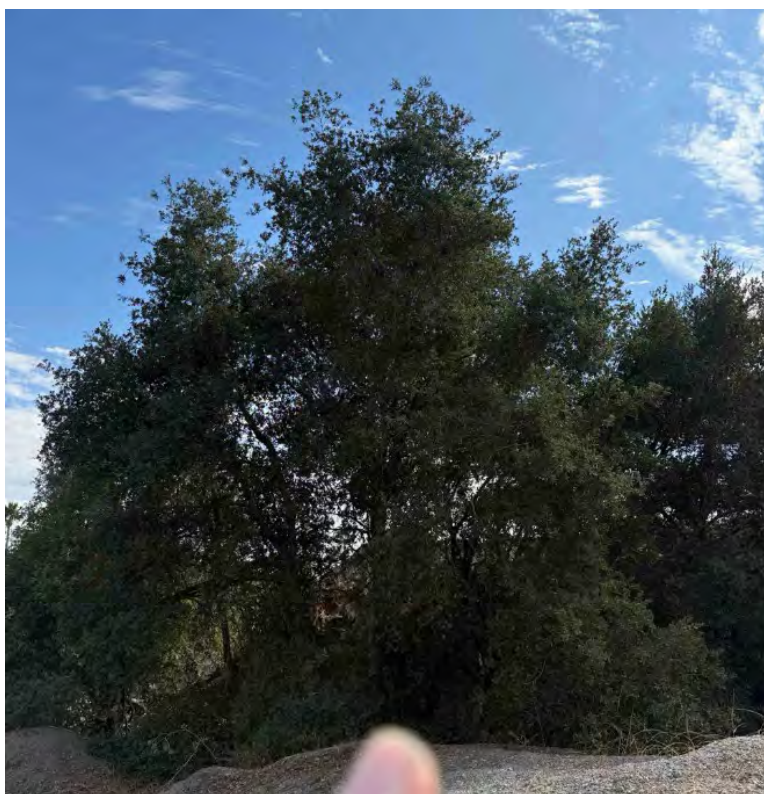
Photograph: 82. TREE #336  
Species: Coast Live Oak  
Category: TRE

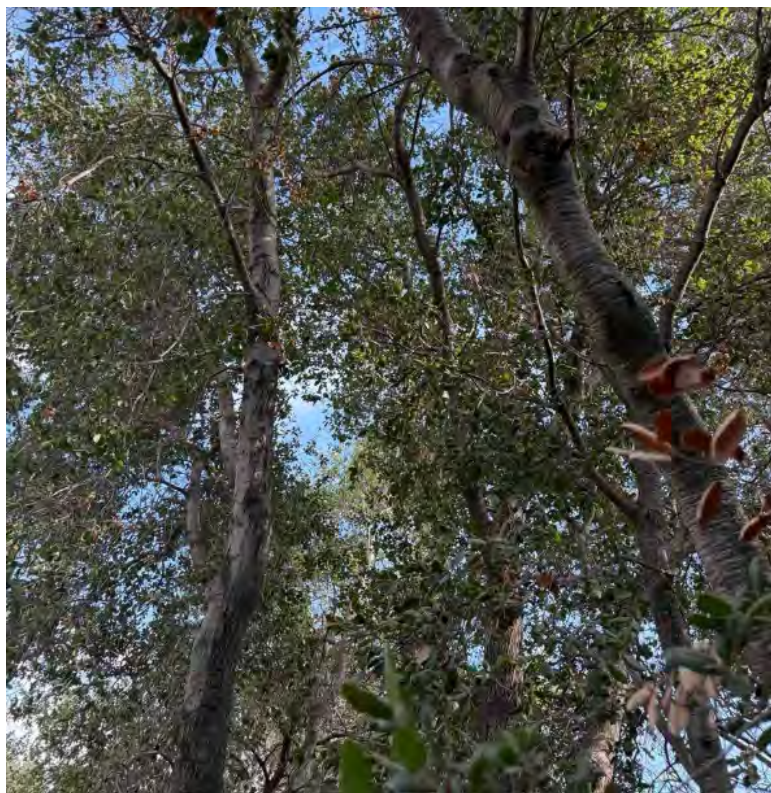
Photograph: 83. TREE #337  
Species: Coast Live Oak  
Category: TRE

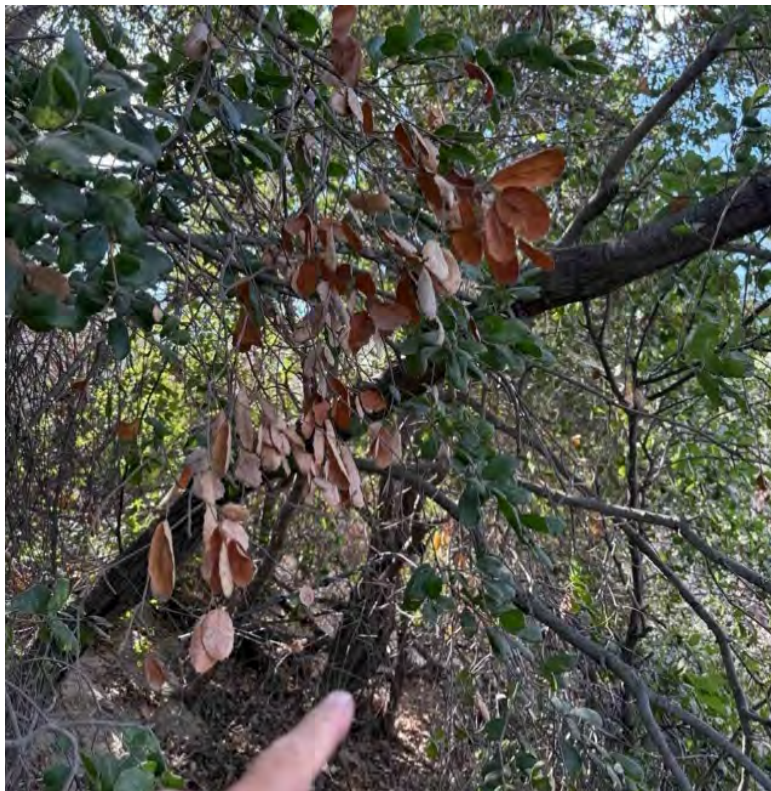
Photograph: 85. TREE 340  
Species: Coast Live Oak  
Category: TRE

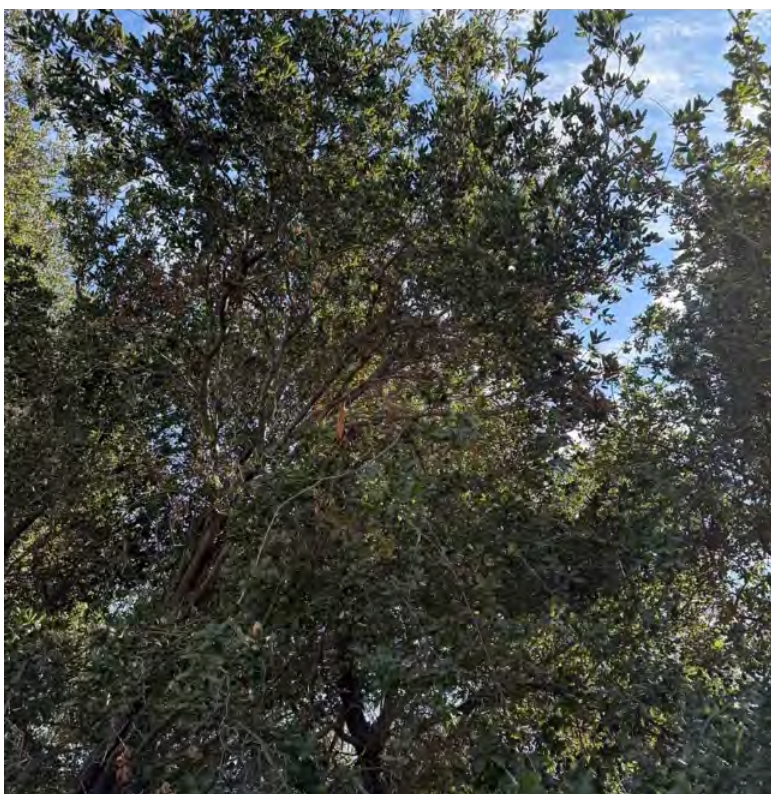
Photograph: 86. TREE 341  
Species: Coast Live Oak  
Category: TRE with Intensive Mitigation

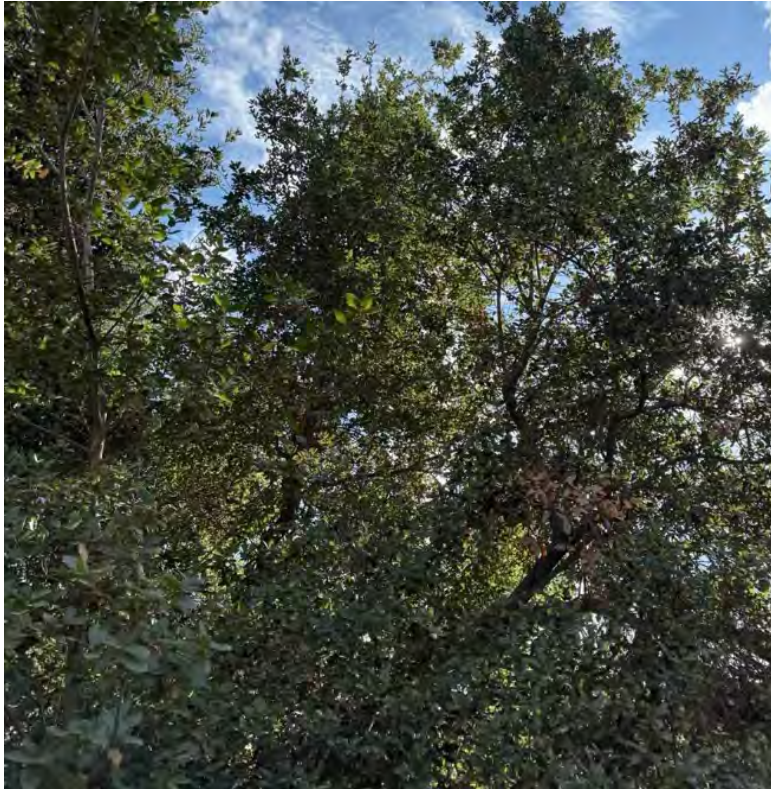
Photograph: 87. TREE #342  
Species: Coast Live Oak  
Category: TRH

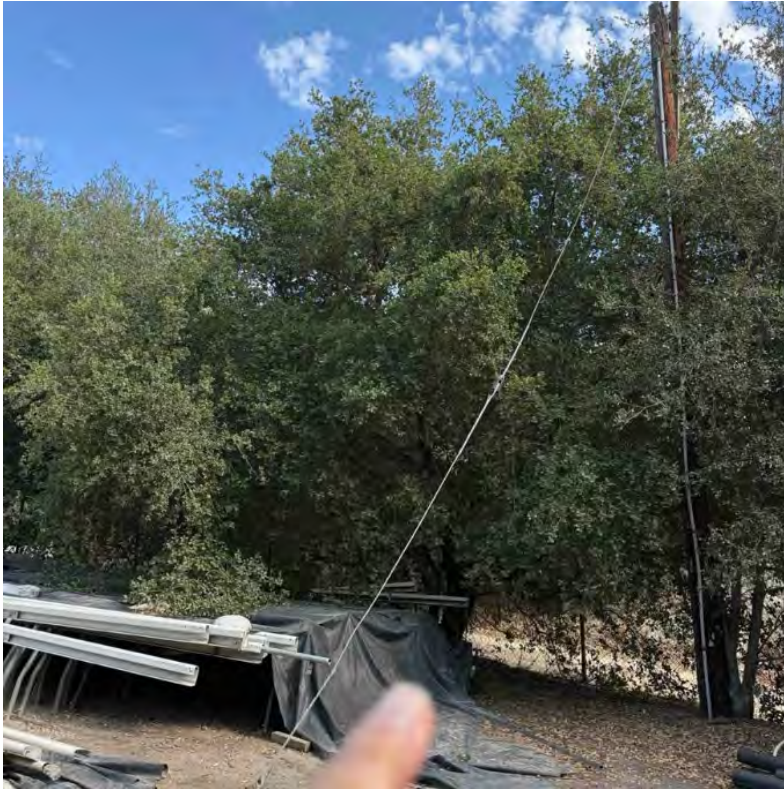
Photograph: 88. TREE #343  
Species: Coast Live Oak  
Category: TRH

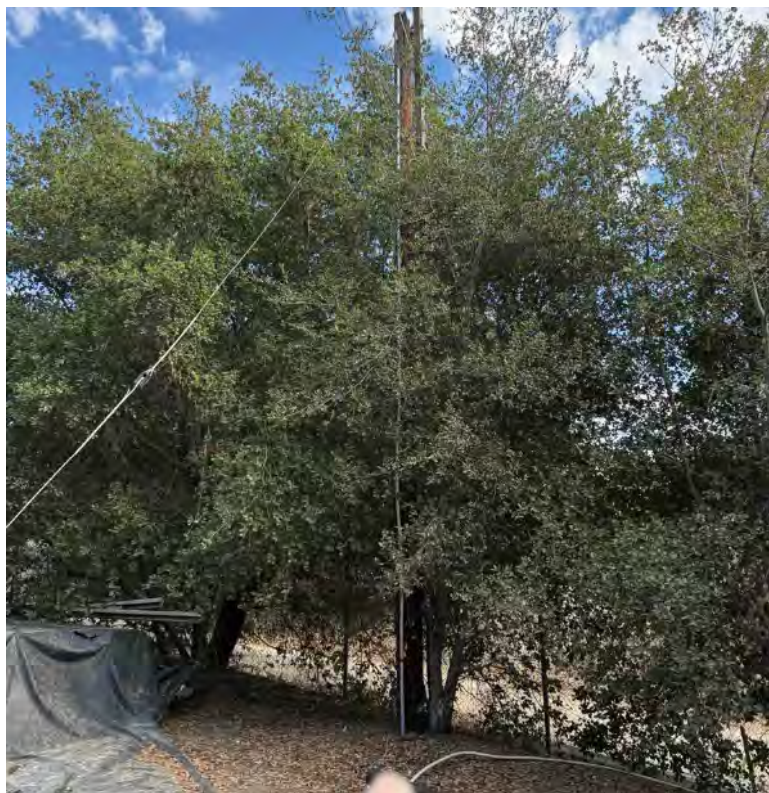
Photograph: 89. TREE #344  
Species: Coast Live Oak  
Category: TRE

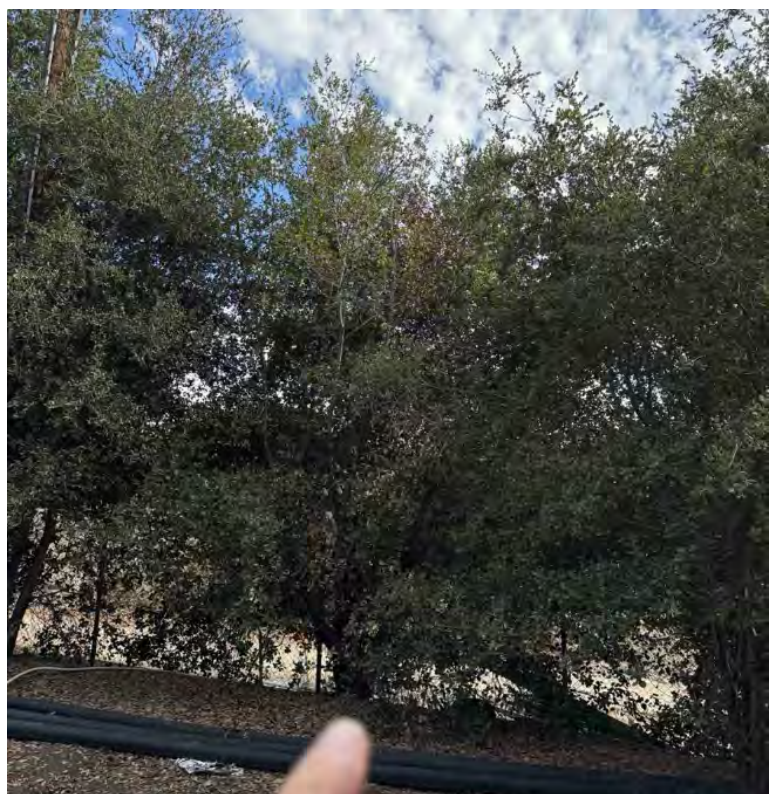
Photograph: 90. TREE #345  
Species: Coast Live Oak  
Category: TRE with Intensive Mitigation

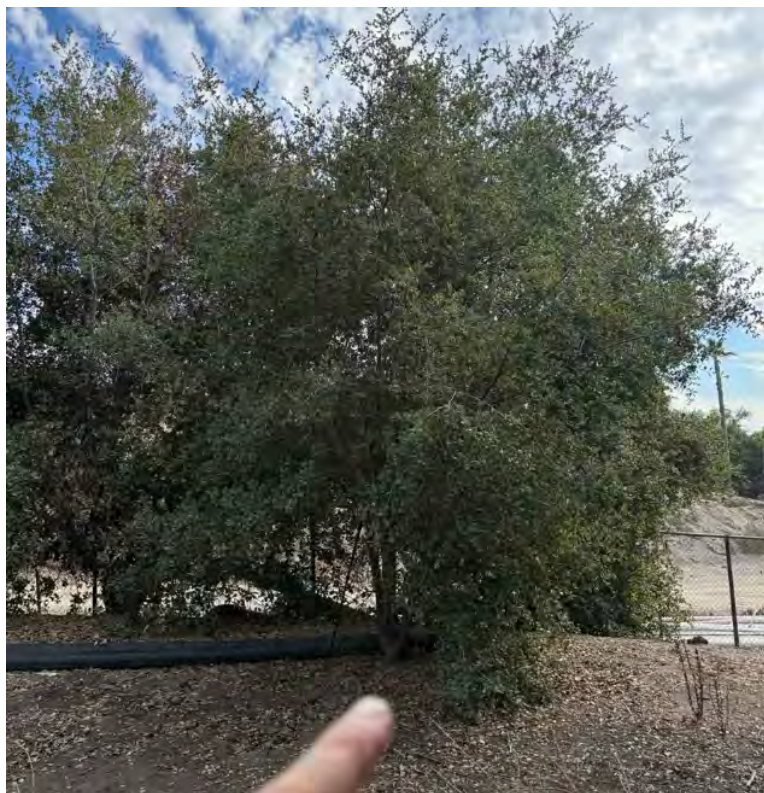
Photograph: 91. TREE #346  
Species: Coast Live Oak  
Category: Protect in place, Avoid

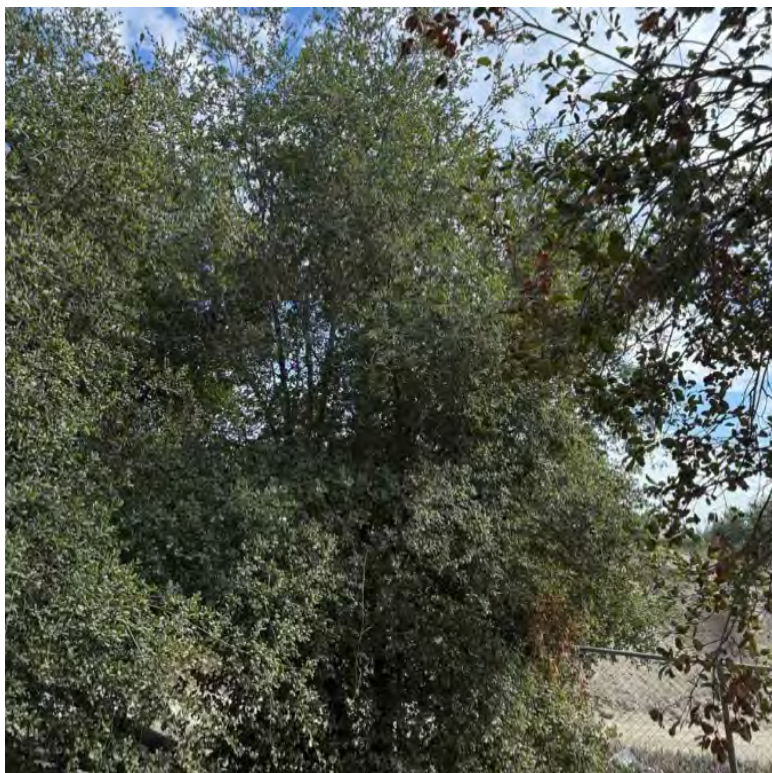
Photograph: 92. TREE #347  
Species: Coast Live Oak  
Category: TRE with Intensive Mitigation
