# **Protected Tree Assessment and Arborist Inventory Report LA28 Equestrian Course Grading Plan**

## **Prepared for**

Los Angeles Turf Club  
285 W Huntington Drive  
Arcadia, CA 91107  
Contact: Ms. Nicola Boon  
Phone: (760) 213 0963  
Email: niciboon@nbicassociates.com

June 2026

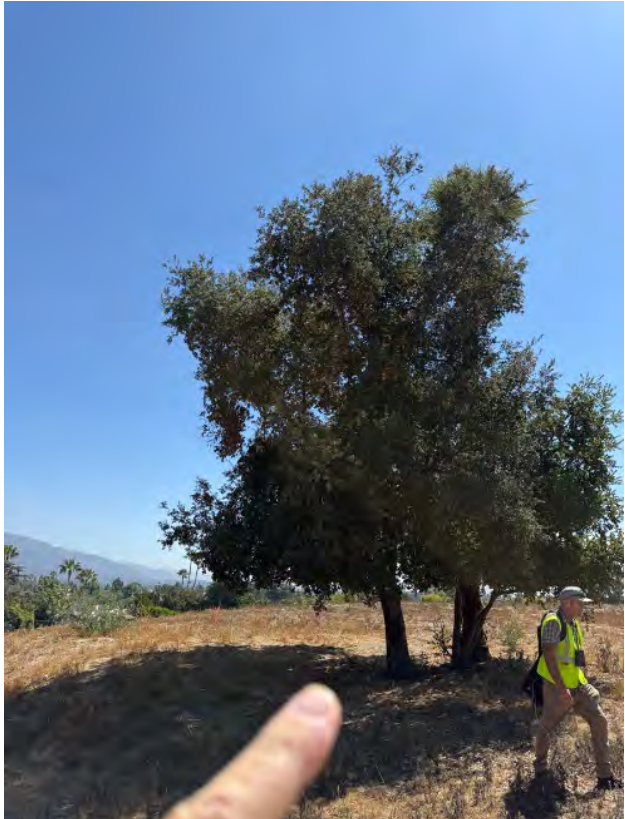
| <b>Tree</b> | <b>Common</b> | <b>Scientific</b> | <b>DSH<br/>(Inches)</b> | <b>Ht<br/>(Feet)</b> | <b>Vigor</b> | <b>Crown<br/>(Feet)</b> | <b>Density</b> | <b>TPZ<br/>%</b> | <b>TPZ<br/>Diameter</b> | <b>Severity</b> | <b>Retention<br/>Feasibility</b> | <b>Permit<br/>Recommendation</b> |
|---|---|---|---|---|---|---|---|---|---|---|---|---|
| 13 | Coast Live Oak | <i>Quercus agrifolia</i> | 15 | 35 | High | 15 | Normal | 37 | 15 | Extreme | Feasible only with intensive mitigation and arborist hold points | TRE encroachment permit with intensive mitigation recommended |

| | <p>Photograph: 2. TREE #13<br/>Species: Coast Live Oak<br/>Category: TRE with Intensive Mitigation</p> |

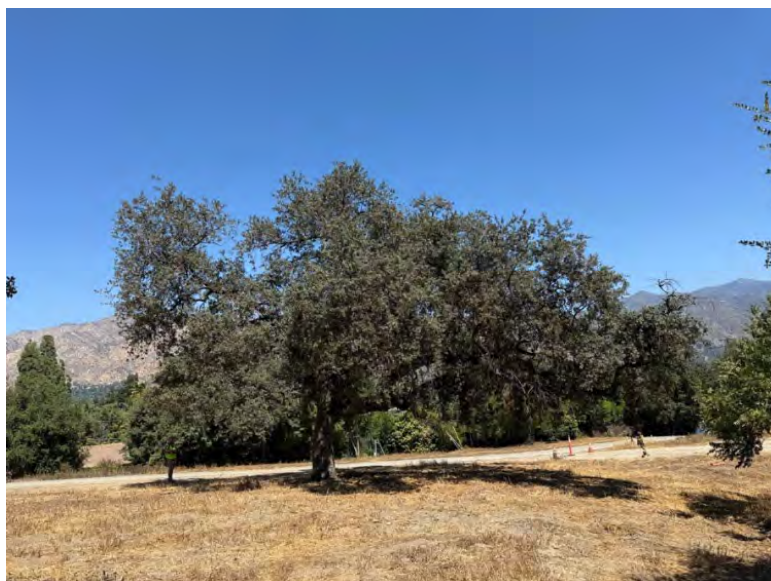
| <b>Tree</b> | <b>Common</b> | <b>Scientific</b> | <b>DSH<br/>(Inches)</b> | <b>Ht<br/>(Feet)</b> | <b>Vigor</b> | <b>Crown<br/>(Feet)</b> | <b>Density</b> | <b>TPZ<br/>%</b> | <b>TPZ<br/>Diameter</b> | <b>Severity</b> | <b>Retention<br/>Feasibility</b> | <b>Permit<br/>Recommendation</b> |
|---|---|---|---|---|---|---|---|---|---|---|---|---|
| 19 | Engelmann Oak (Mesa Oak) | <i>Quercus engelmannii</i> | 28 | 40 | Normal | 39 | Normal | 71 | 39 | Extreme | Removal recommended; TRD/hazard pathway may be evaluated if confirmed by signing arborist and City | TRH removal recommended; evaluate TRD if condition/hazard status confirmed |

Photograph: 6. TREE #19  
Species: Engelmann Oak  
Category: TRH

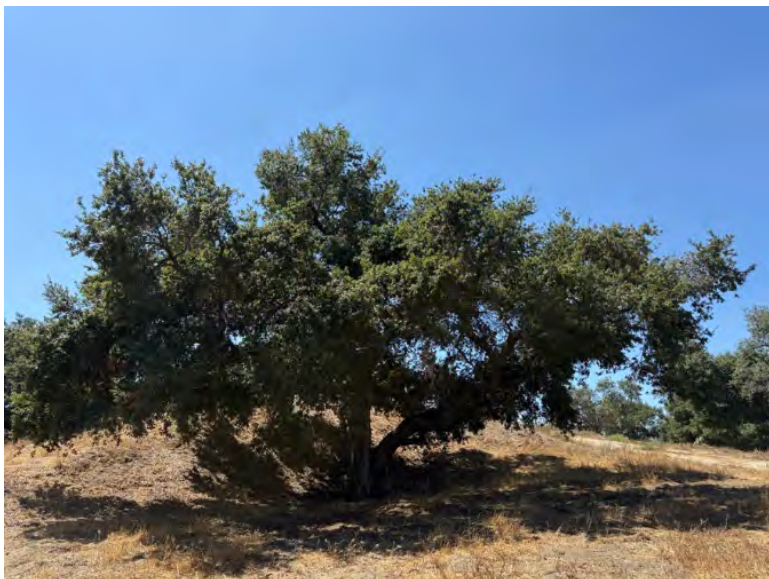
| <b>Tree</b> | <b>Common</b> | <b>Scientific</b> | <b>DSH<br/>(Inches)</b> | <b>Ht<br/>(Feet)</b> | <b>Vigor</b> | <b>Crown<br/>(Feet)</b> | <b>Density</b> | <b>TPZ<br/>%</b> | <b>TPZ<br/>Diameter</b> | <b>Severity</b> | <b>Retention<br/>Feasibility</b> | <b>Permit<br/>Recommendation</b> |
|---|---|---|---|---|---|---|---|---|---|---|---|---|
| 21 | Coast Live Oak | <i>Quercus agrifolia</i> | 45 | 40 | Normal | 34 | Normal | 77 | 34 | Extreme | Feasible only with intensive mitigation and arborist hold points | TRE encroachment permit with intensive mitigation recommended |

Photograph: 8. TREE #21  
Species: Coast Live Oak  
Category: TRE with Intensive Mitigation

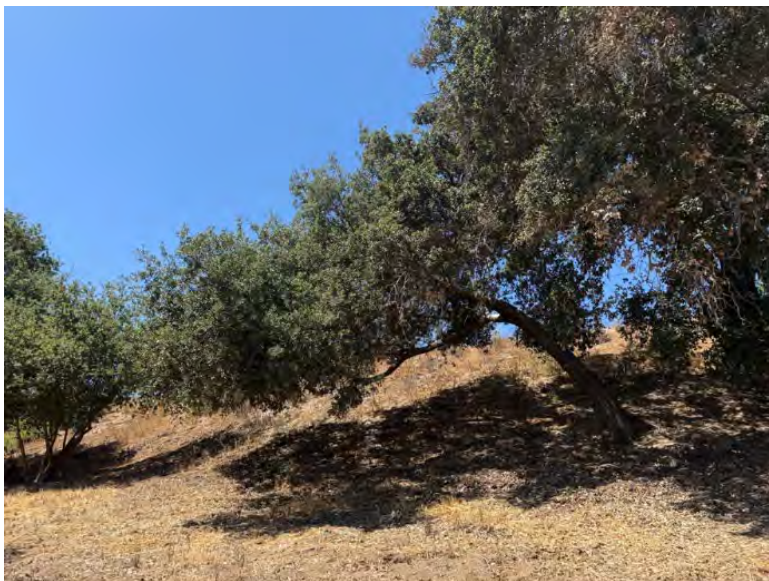
Photograph: 14. TREE #33  
Species: Coast Live Oak  
Category: TRE with Intensive Mitigation

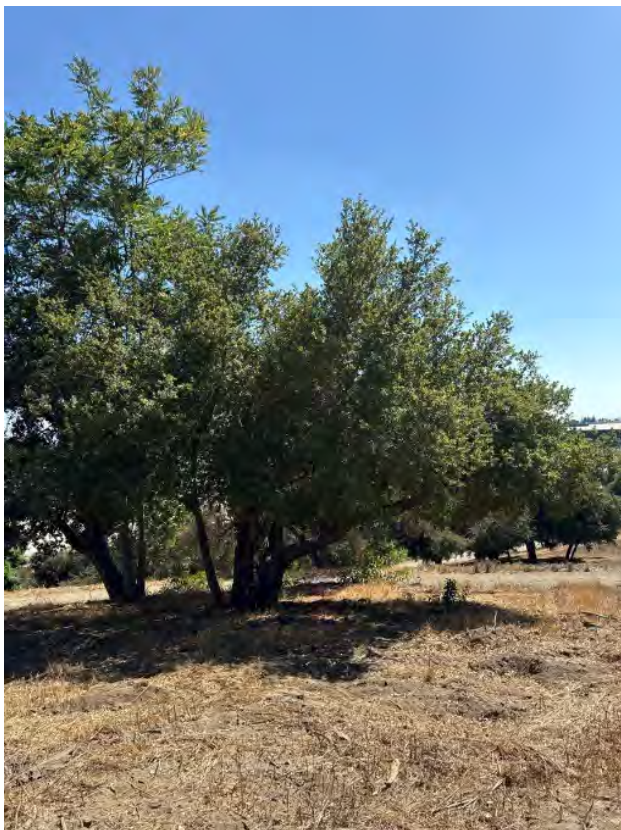
Photograph: 19. TREE # 44  
Species: Coast Live Oak  
Category: TRH

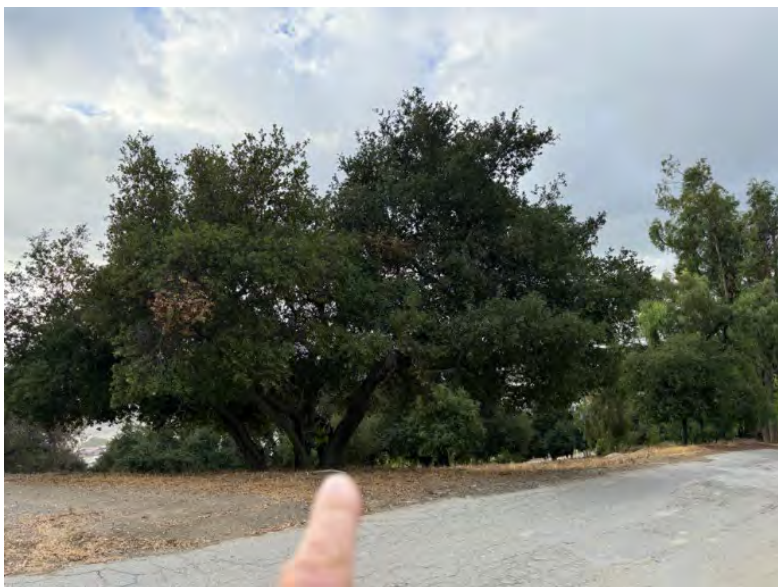
Photograph: 20. TREE #66  
Species: Coast Live Oak  
Category: TRH

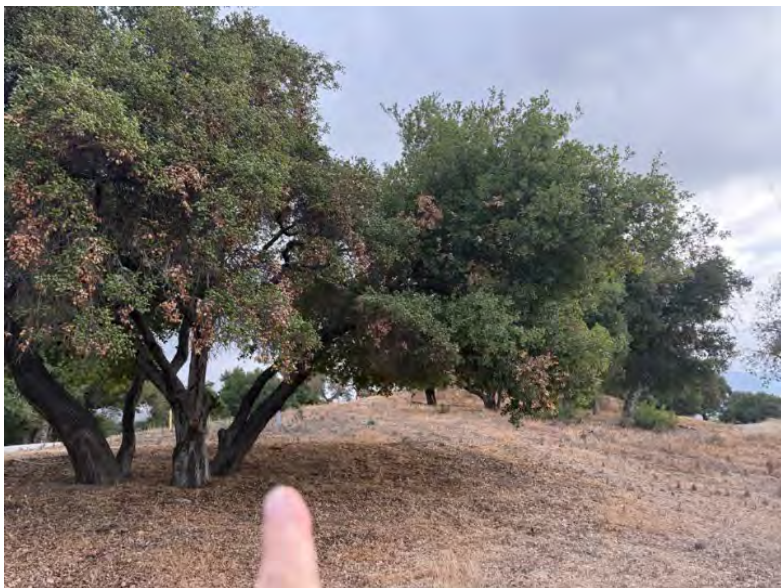
Photograph: 21. TREE #68  
Species: Coast Live Oak  
Category: TRE

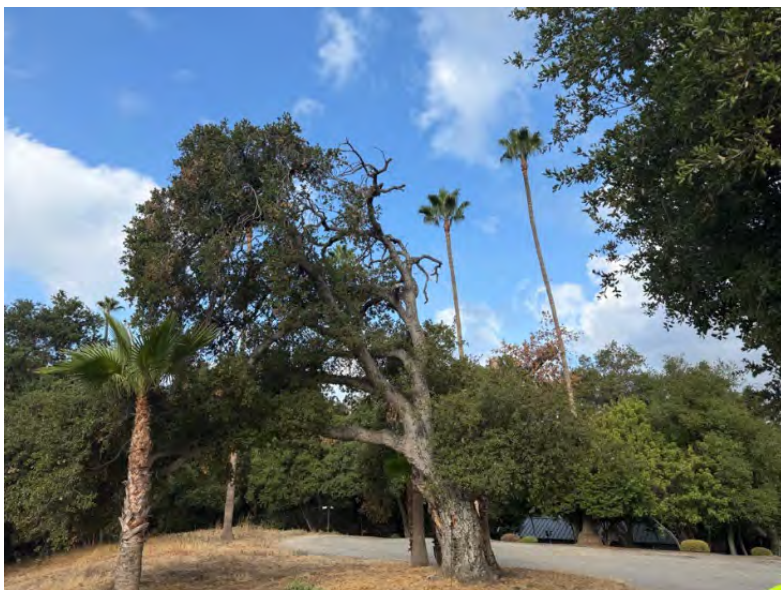
Photograph: 22. TREE # 70  
Species: Coast Live Oak  
Category: TRE with Intensive Mitigation

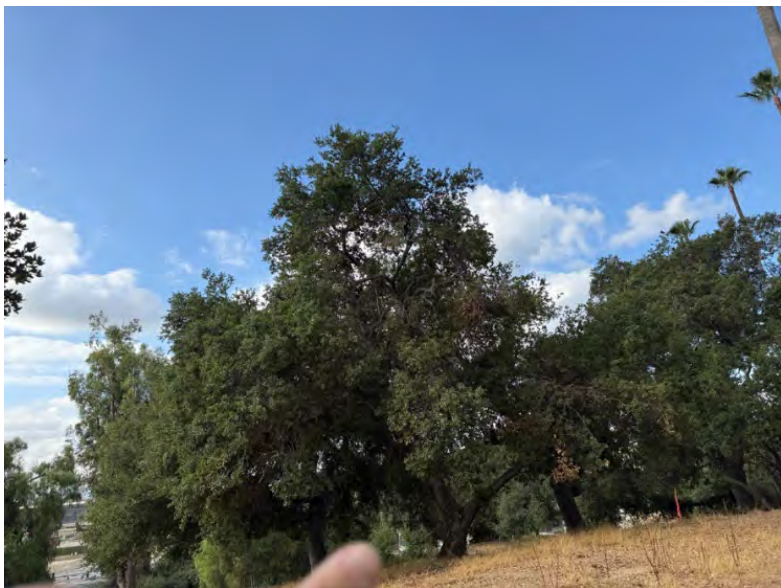
Photograph: 23. TREE #78  
Species: Coast Live Oak  
Category: TRH

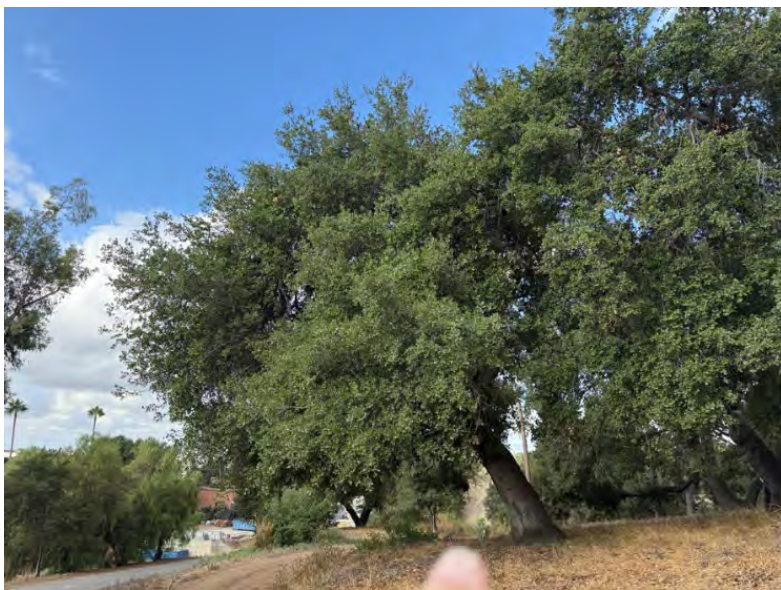
Photograph: 24. TREE #79  
Species: Coast Live Oak  
Category: TRH

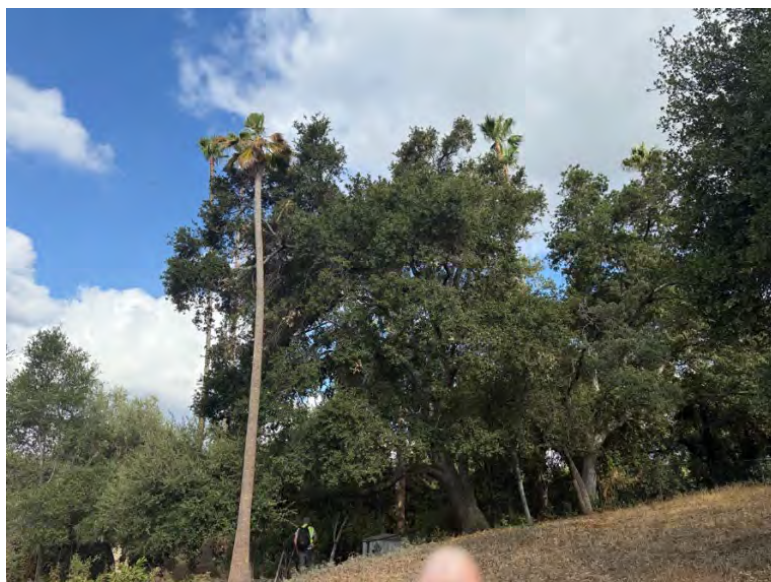
Photograph: 29. TREE #85  
Species: Coast Live Oak  
Category: TRE with Intensive Mitigation

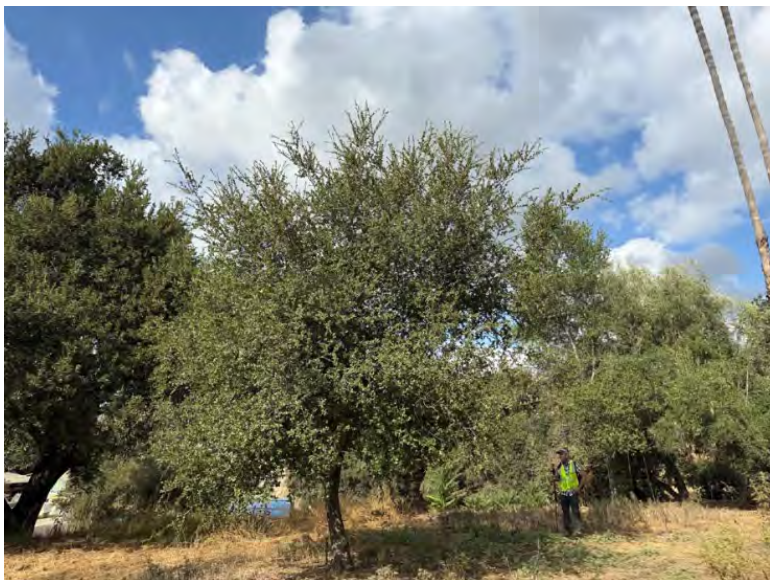
Photograph: 31. TREE #89  
Species: Coast Live Oak  
Category: TRH

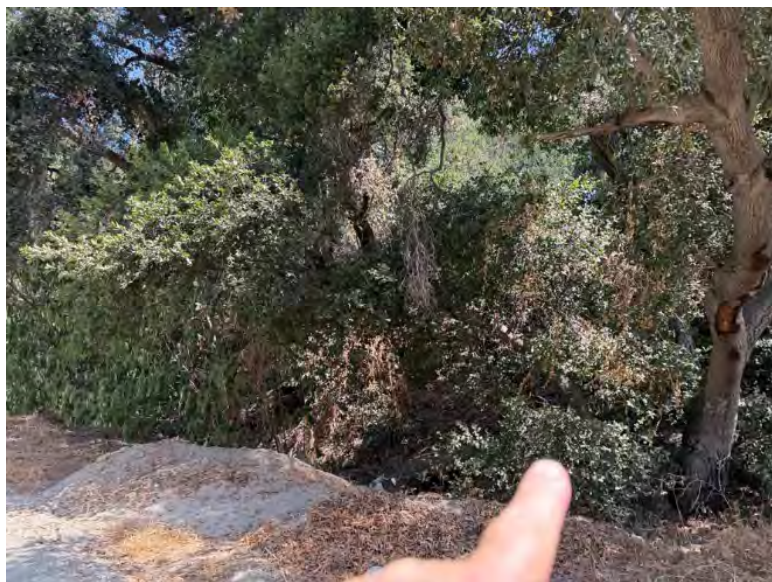
Photograph: 36. TREE # 117  
Species: Coast Live Oak  
Category: TRE with Intensive Mitigation

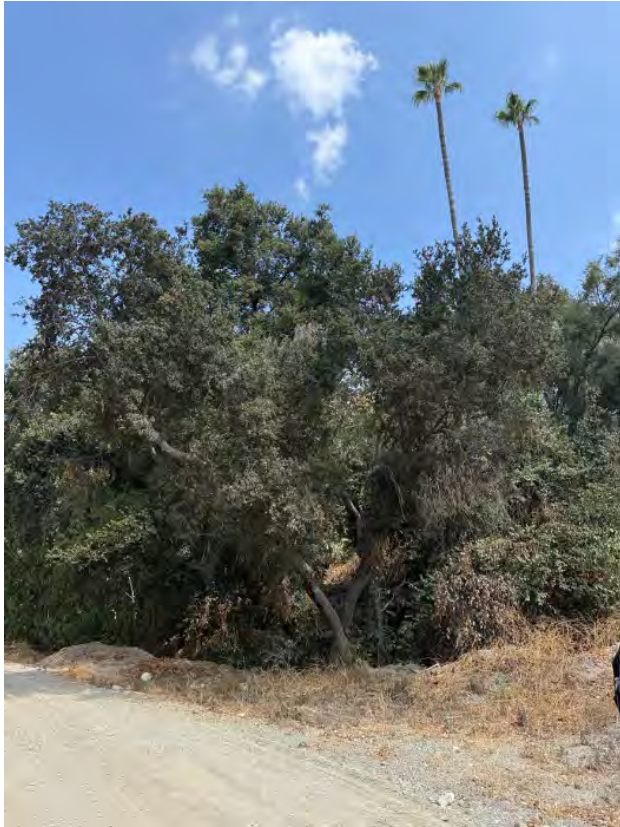
Photograph: 37. TREE #118  
Species: Coast Live Oak  
Category: TRE

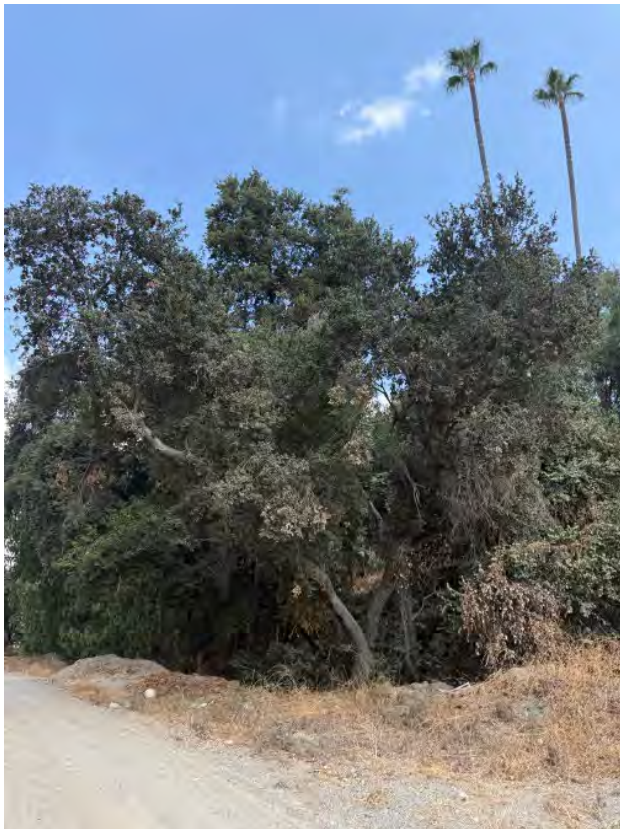
Photograph: 38. TREE #119  
Species: Coast Live Oak  
Category: TRE with Intensive Mitigation

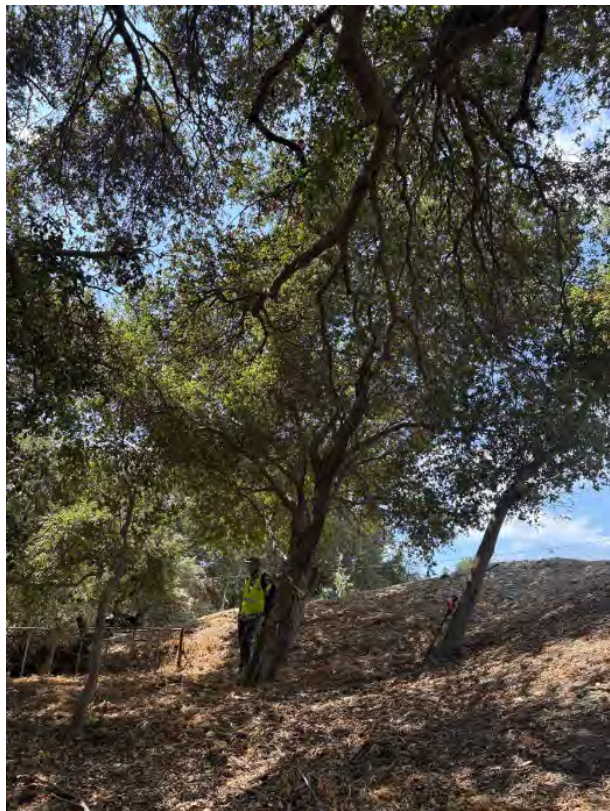
Photograph: 43. TREE #127  
Species: Coast Live Oak  
Category: TRH

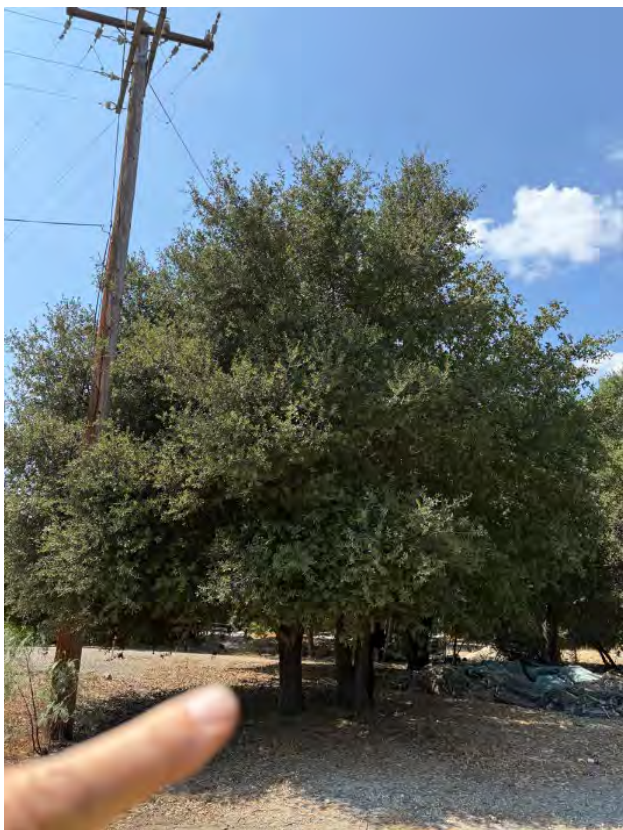
Photograph: 47. TREE #135  
Species: Coast Live Oak  
Category: TRE with Intensive Mitigation

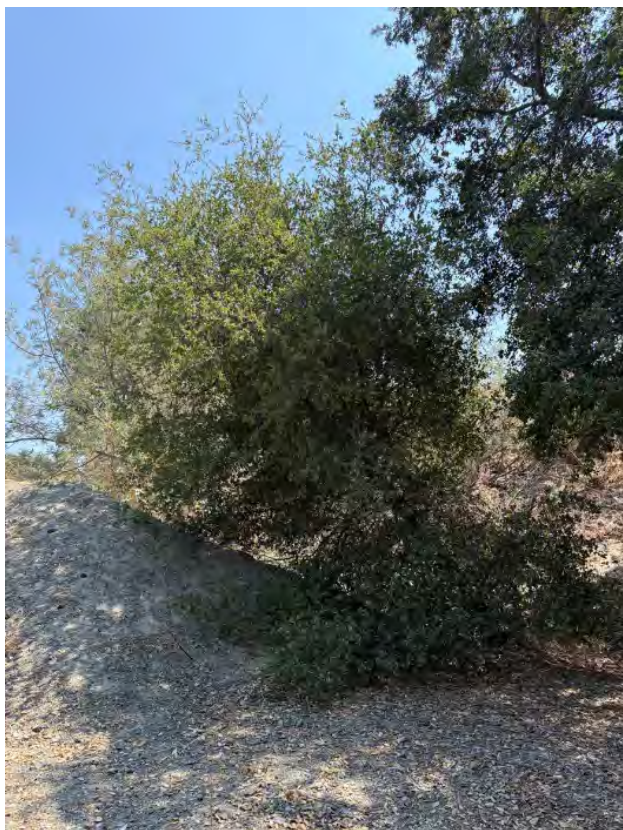
Photograph: 49. TREE #143  
Species: Coast Live Oak  
Category: TRH

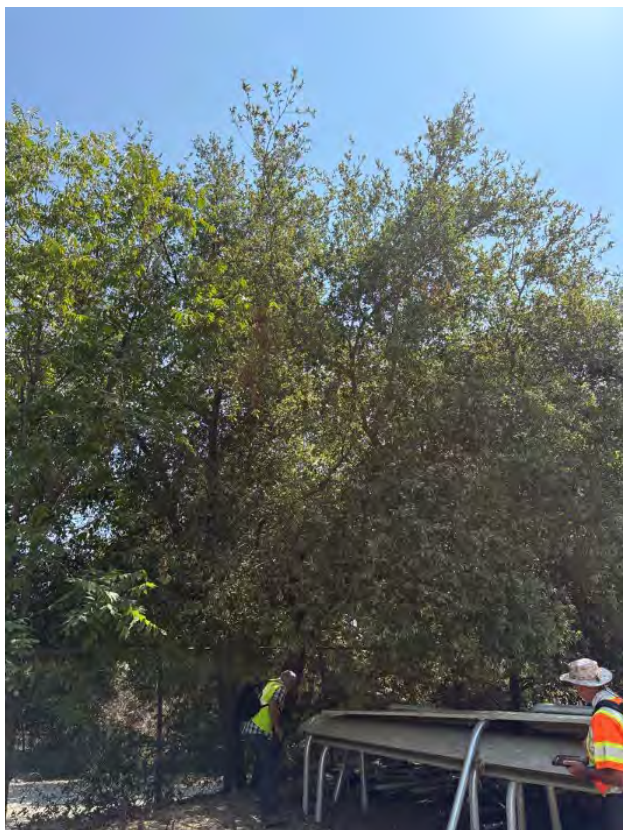
Photograph: 51. TREE #149  
Species: Coast Live Oak  
Category: TRH

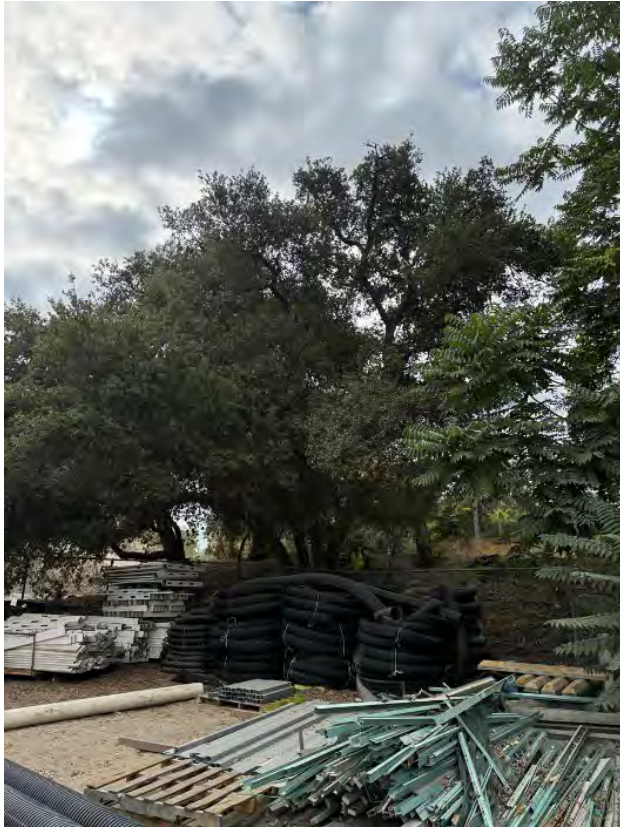
Photograph: 55. TREE #200  
Species: Coast Live Oak  
Category: TRE

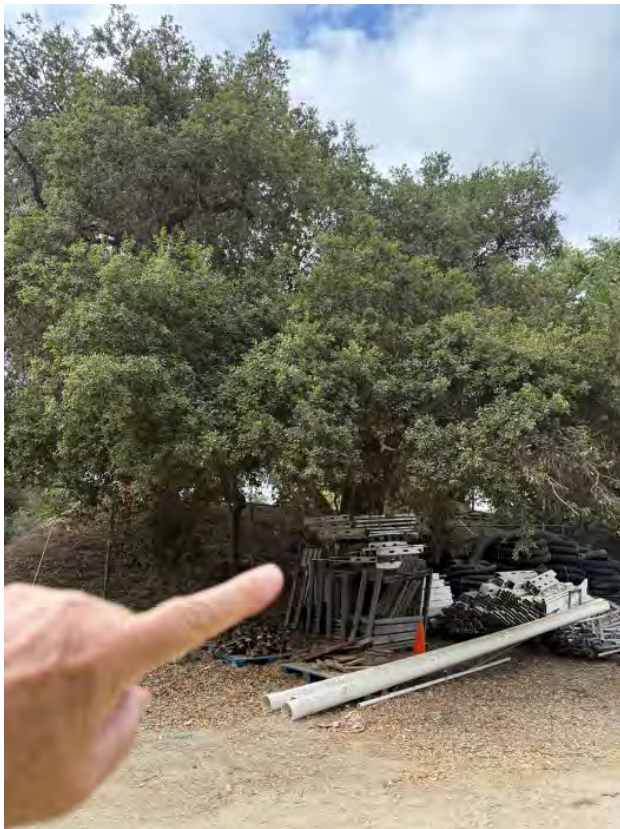
Photograph: 56. TREE #202  
Species: Coast Live Oak  
Category: TRE

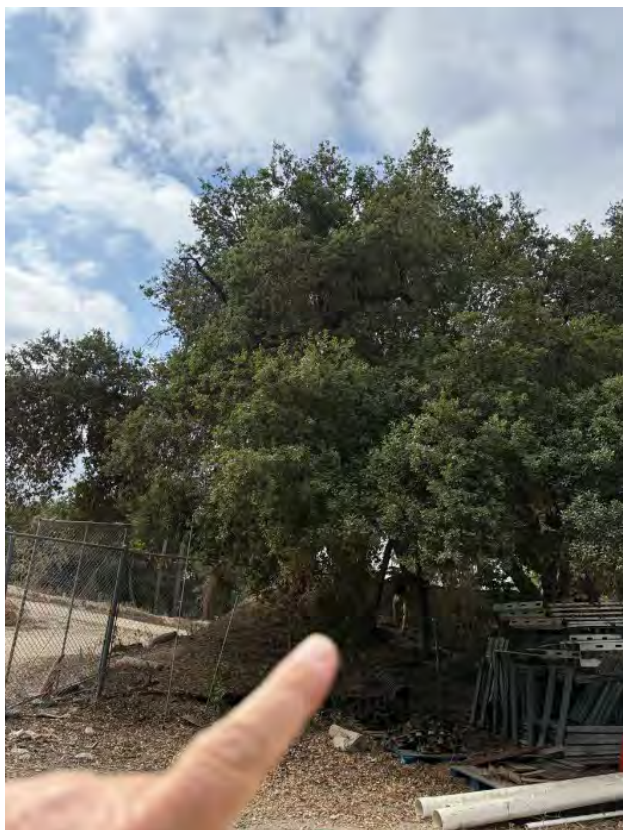
Photograph: 57. TREE #203  
Species: Coast Live Oak  
Category: TRE with Intensive Mitigation

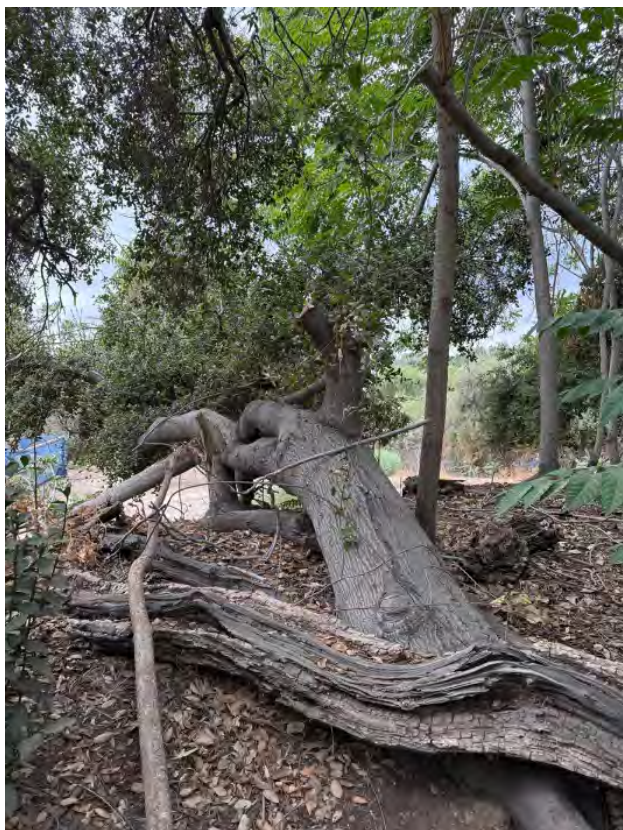
Photograph: 61. TREE #208  
Species: Coast Live Oak  
Category: TRE

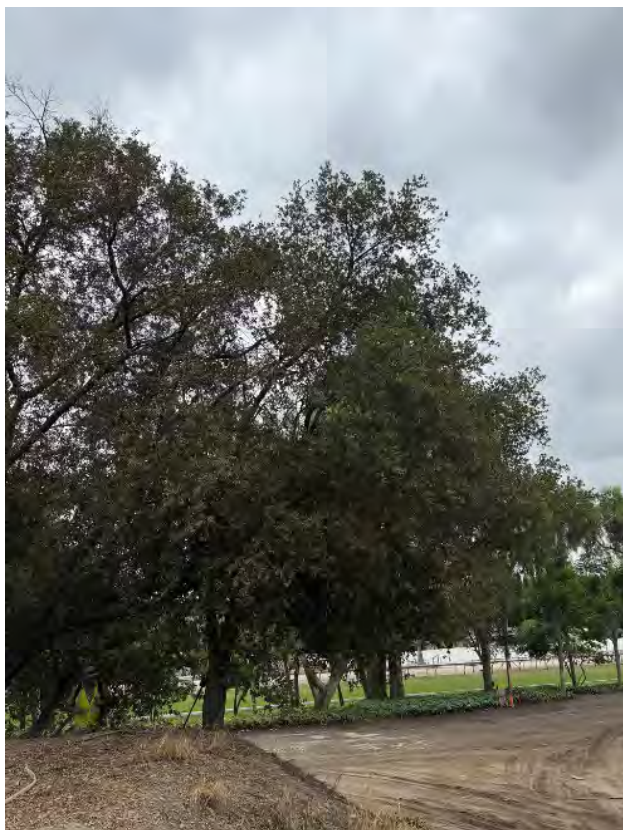
Photograph: 63. TREE #218  
Species: Coast Live Oak  
Category: TRE

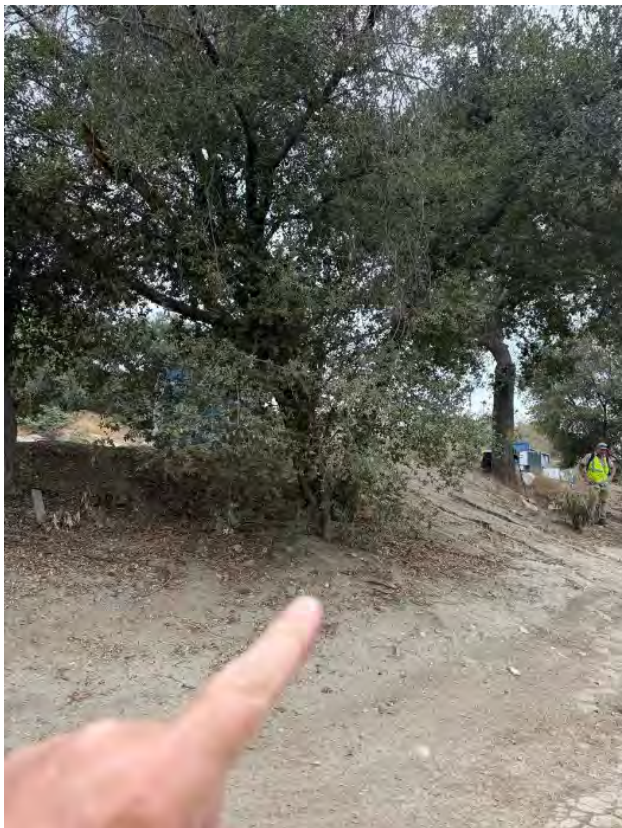
Photograph: 65. TREE #220  
Species: Coast Live Oak  
Category: Protect in place, Avoid

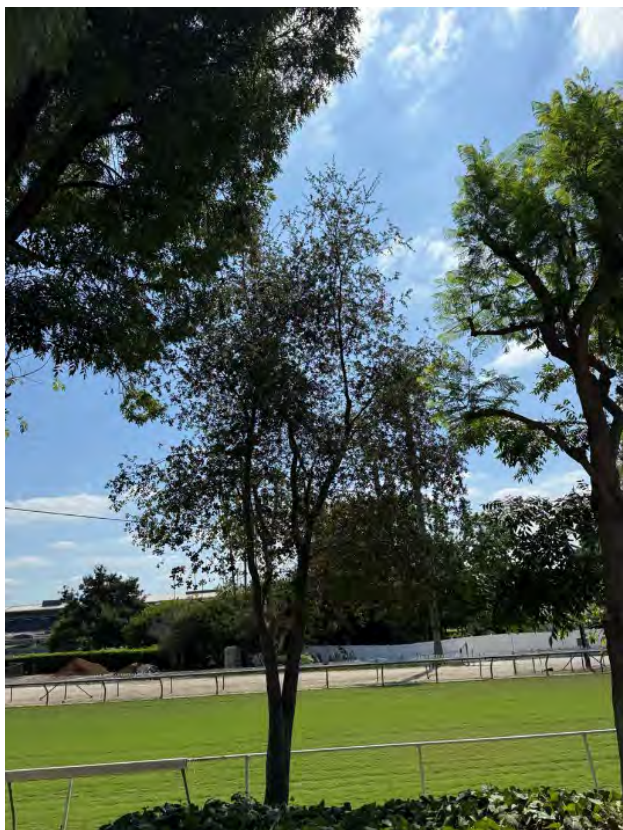
Photograph: 67. TREE #263  
Species: Coast Live Oak  
Category: TRH

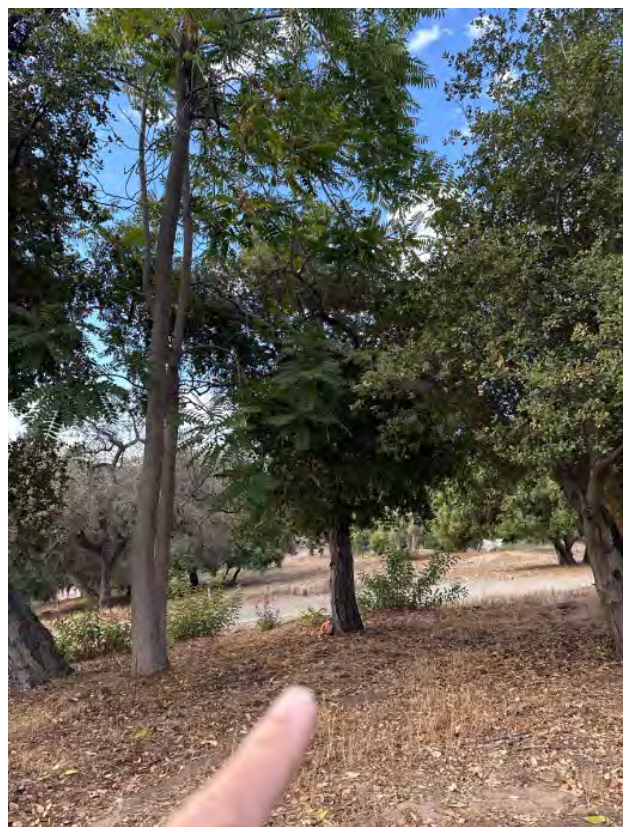
Photograph: 68. TREE #290  
Species: Coast Live Oak  
Category: TRE

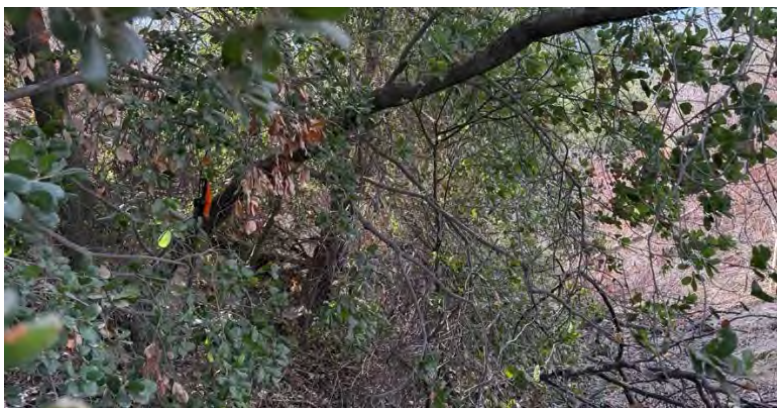
Photograph: 84. TREE #338  
Species: Coast Live Oak  
Category: Protect in place, Avoid
